North Deniliquin Levee Upgrade Feasibility Report

F8480

Project Name	North Deniliquin Levee Upgrade Feasibility Report
Version Number	2
Client	Edward River Council
Report Authors	Price Merrett
PMC Project Reference	F8480

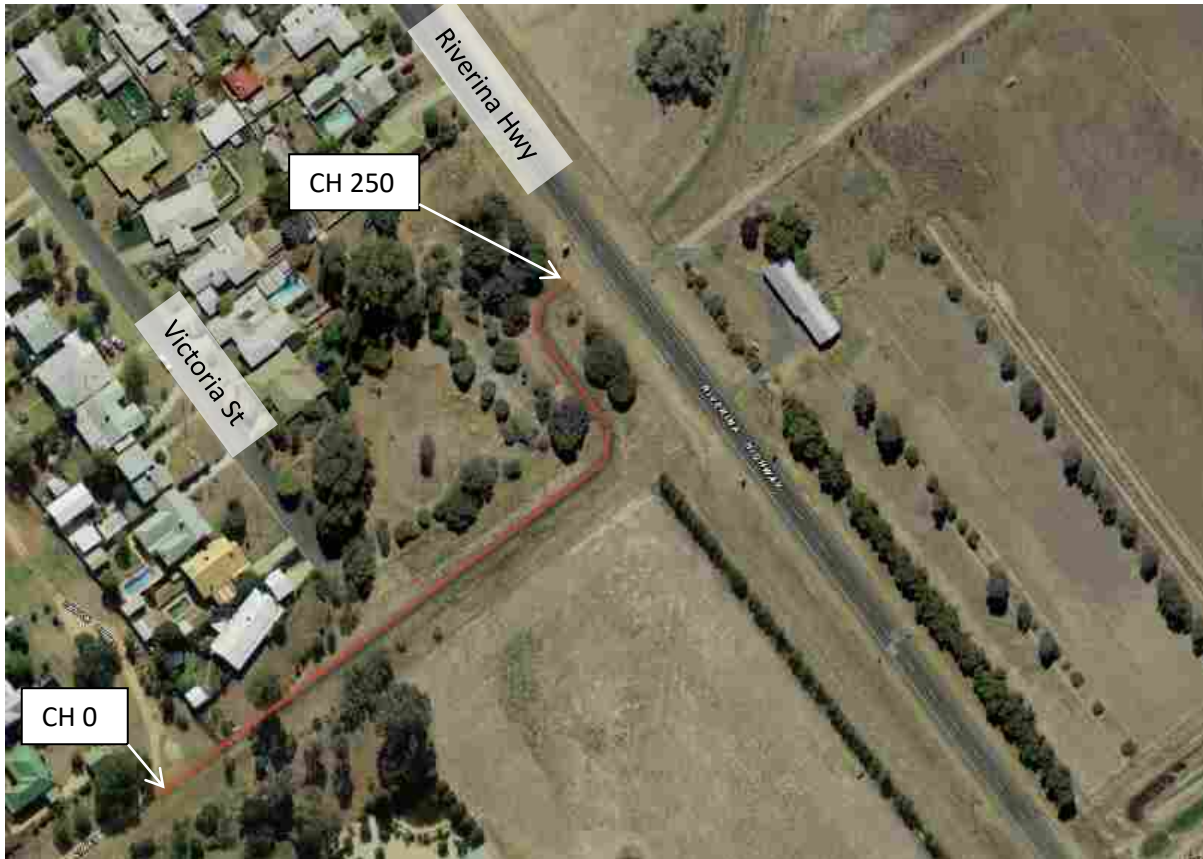
The existing earth levee bank is approximately 1m high, 3.5m crest width and 5:1 batters. The levee needs to be raised around 500mm to achieve design freeboard. Raising the existing bank is the most economical and practical option to achieve the required level of protection.

Figure 8: Section 1 Lagoon Street to Riverina Highway

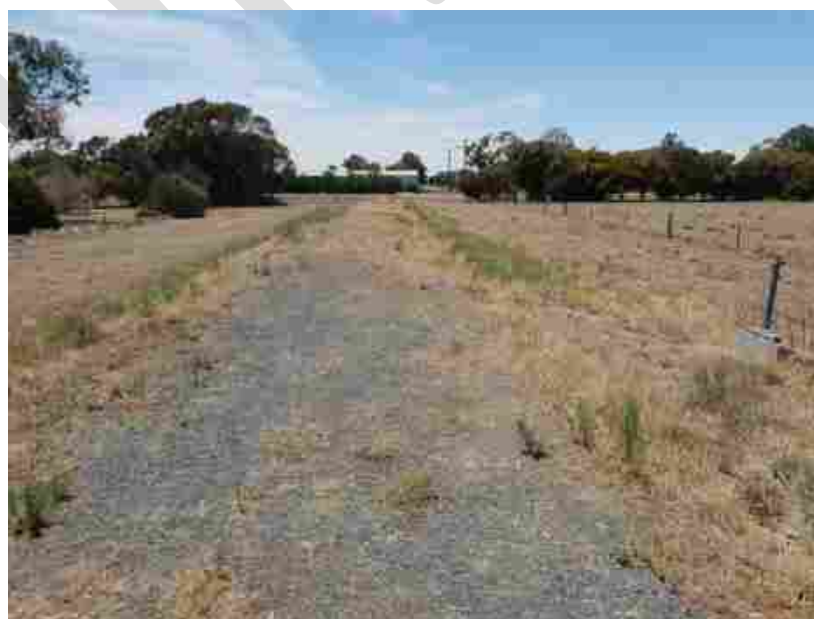
Figure 9: Section 1 midway looking towards highway

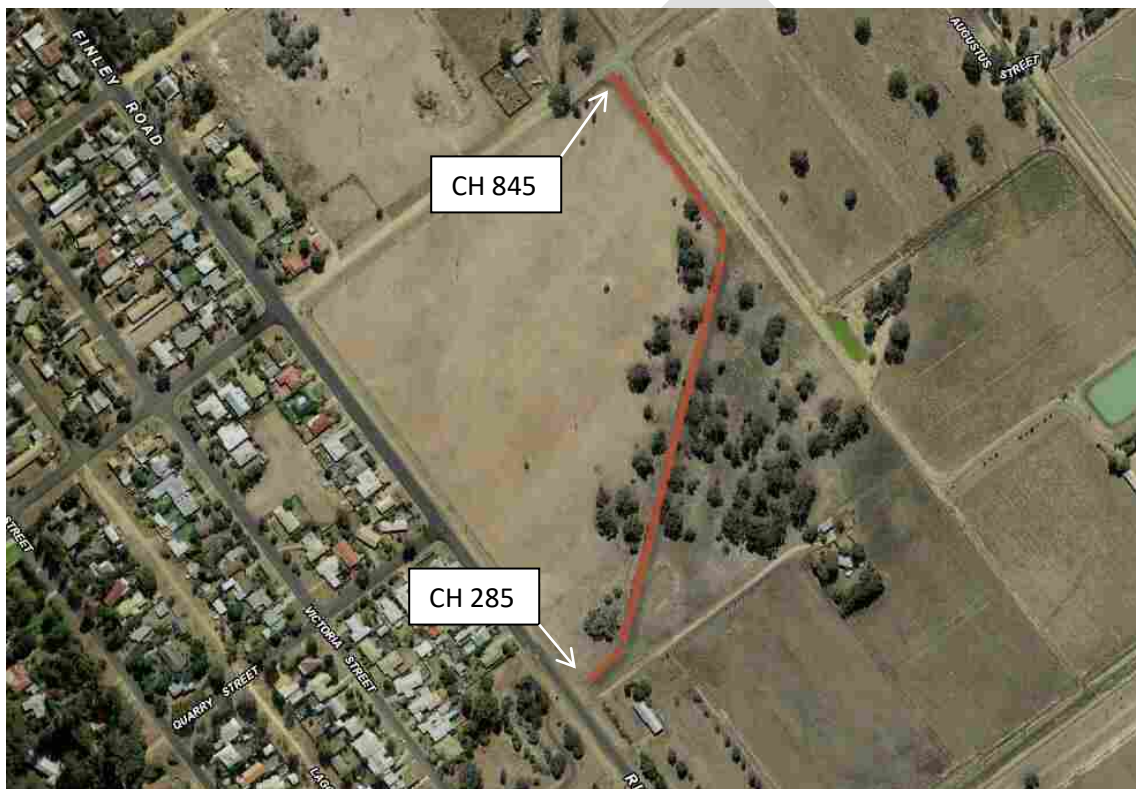
This section will have construction constraints due to existing native vegetation adjacent to the toe of the existing bank. Traffic management requirements would increase if vehicles need to gain access via the Riverina Highway. It is likely that this can be mitigated through the main construction access off Coborro Street during works.

Figure 11: Riverina Highway to Coborro Street

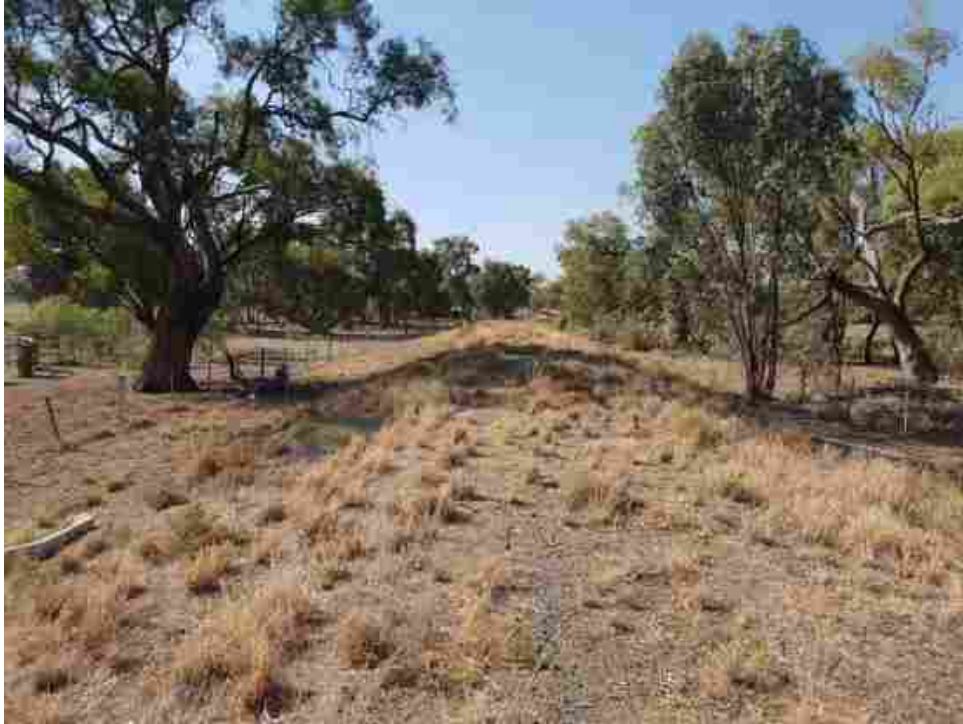
Figure 12: Looking North CH 480 Section 2

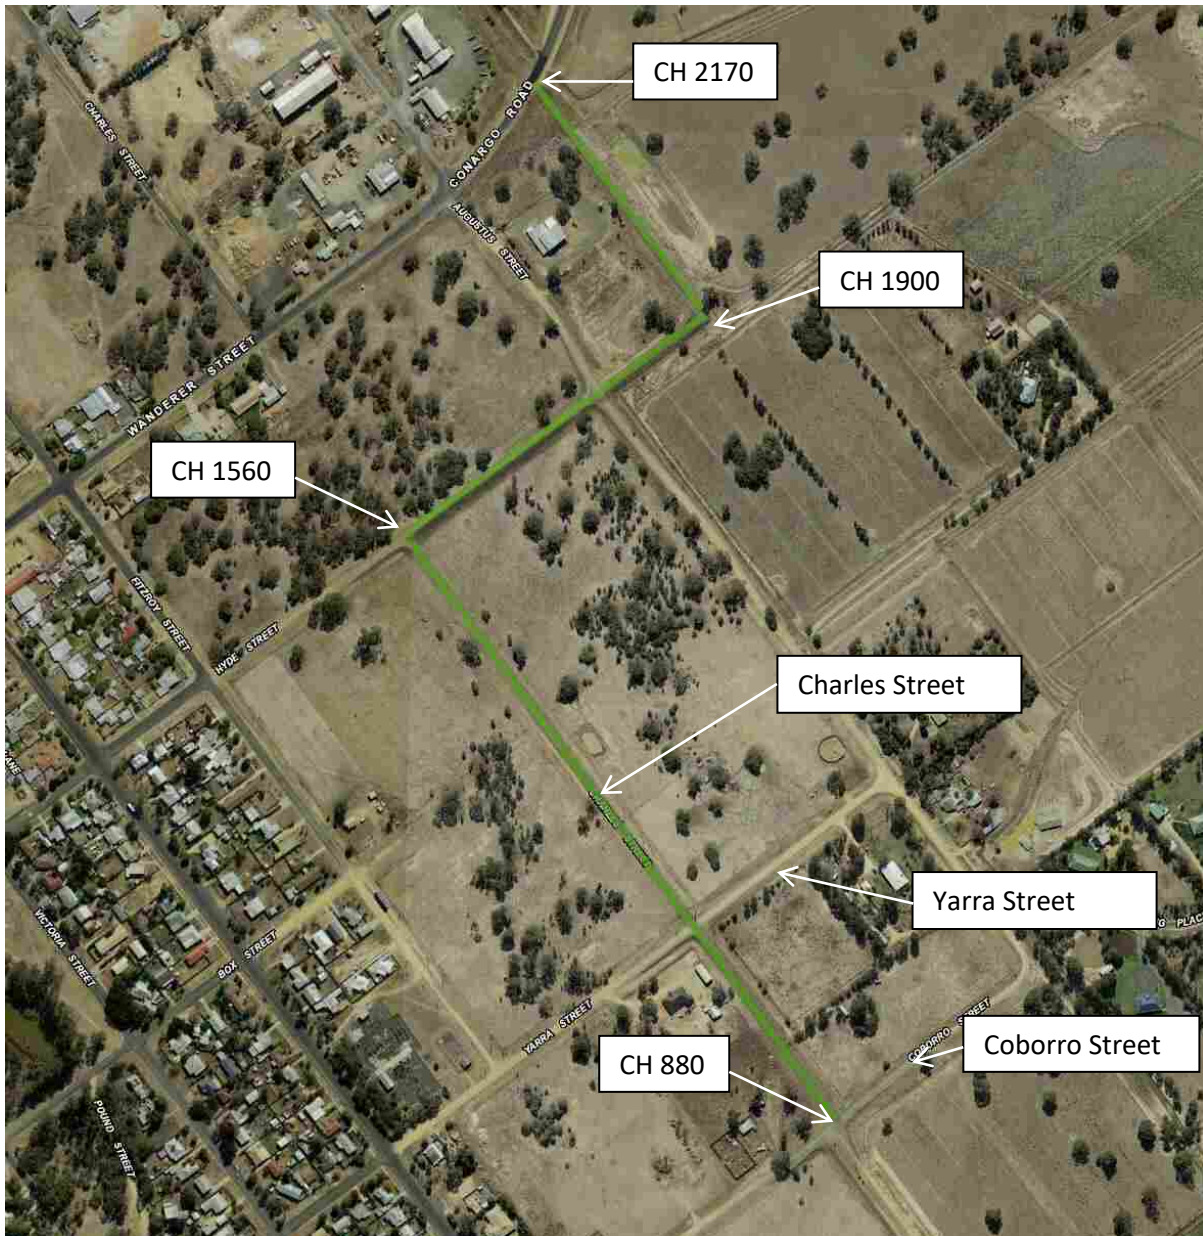
The section of bank between Coborro Street and the Conargo Highway is made up of raised roads and banks. The levee is 1.5m high at the south and increases to 2m near Conargo Road. The crest width is around 3.5m and is generally 1m above the 1% flood level. The batters are 3:1 both wet and dry sides. Therefore no works are proposed.

Figure 13: Coborro Street to Conargo Highway

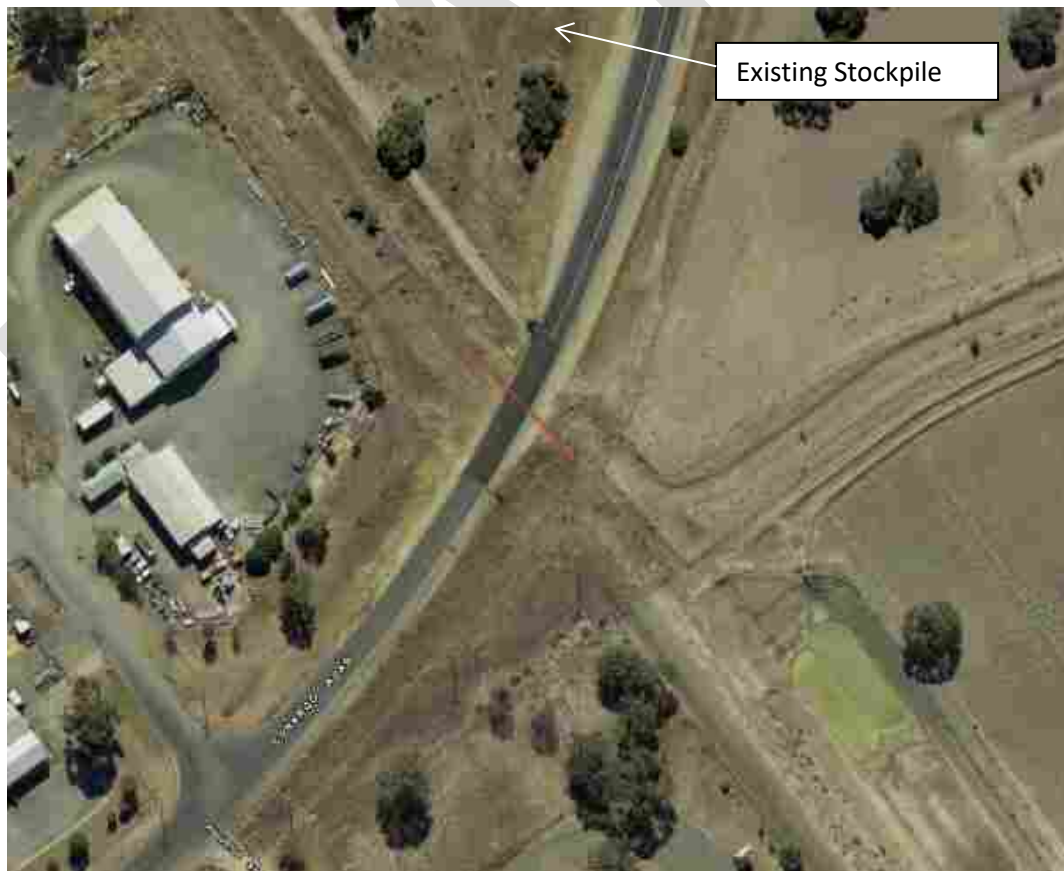
The crossing point is located on a bend with superelevation so there is one-way crossfall on the road falling towards the north. Figure 12 of the WMA report shows a 0.5m flood level difference across the Highway. The table drain on the south will require 1.65m of fill to meet the 1% flood level so approximately 2.2m to provide 500mm freeboard.

Topsoil would need to be stripped during the temporary filling of the sidecut. The total fill required for the crossing is approximately 380m³ which with suitable construction equipment and good material this is not considered a problem.

Figure 14: Conargo Highway Crossing

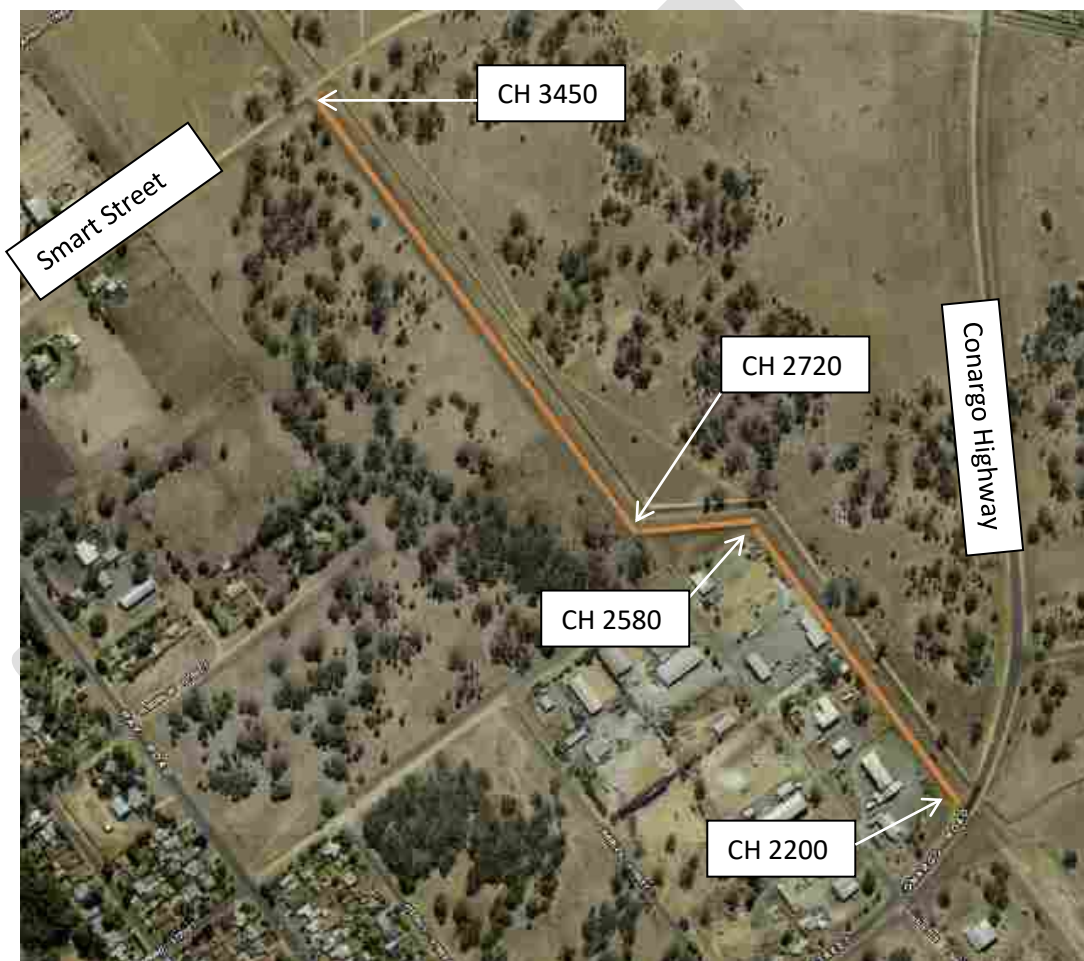
At Smart Street, the existing road centreline is 92.30 which is 500mm above the 1% flood level.

Figure 15: Conargo Highway to Smart Street

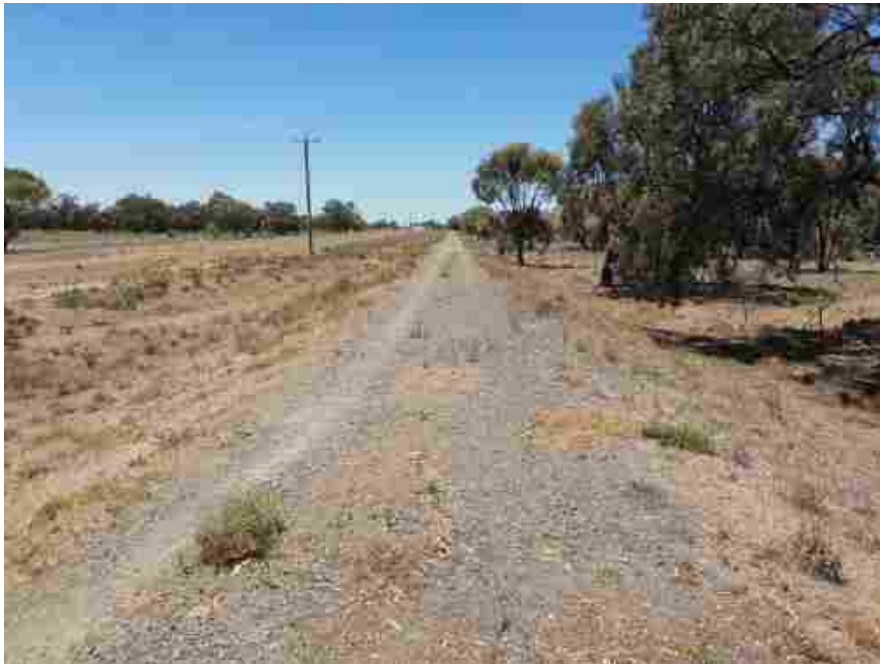
Figure 16: Looking South-East along Flanagans Channel Levee from Smart Street

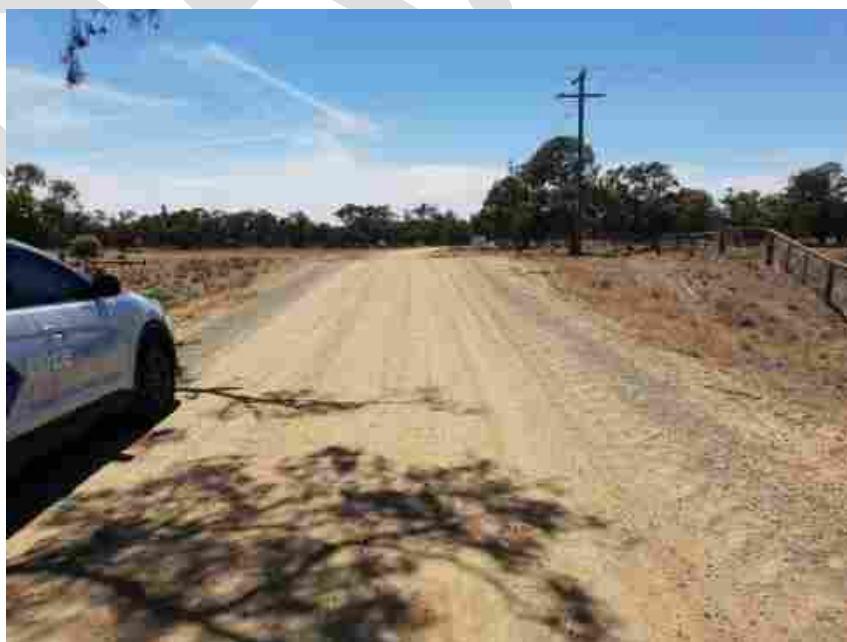
Figure 17: Looking West at Smart Street crossing.

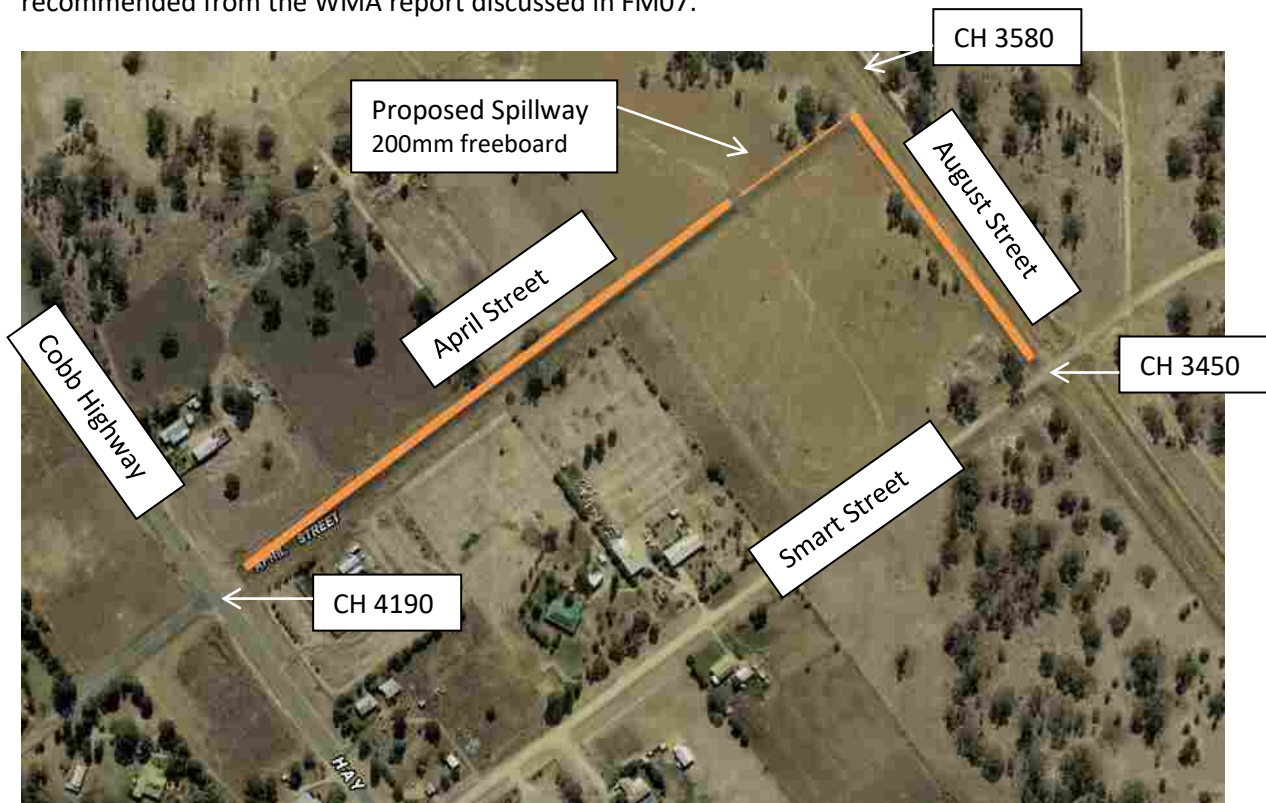
The existing bank from Smart Street to the Cobb Highway is 1m high and requires raising by approximately 200mm to achieve freeboard. The existing bank in the section of August Street has a crest width of 3m and the section in April Street the crest narrows slightly to 2.6m. Batters are generally 4:1 on the dry side and 5:1 on the wet side. There is a proposed spillway which has been recommended from the WMA report discussed in FM07.

Figure 18: Smart Street to Cobb Highway

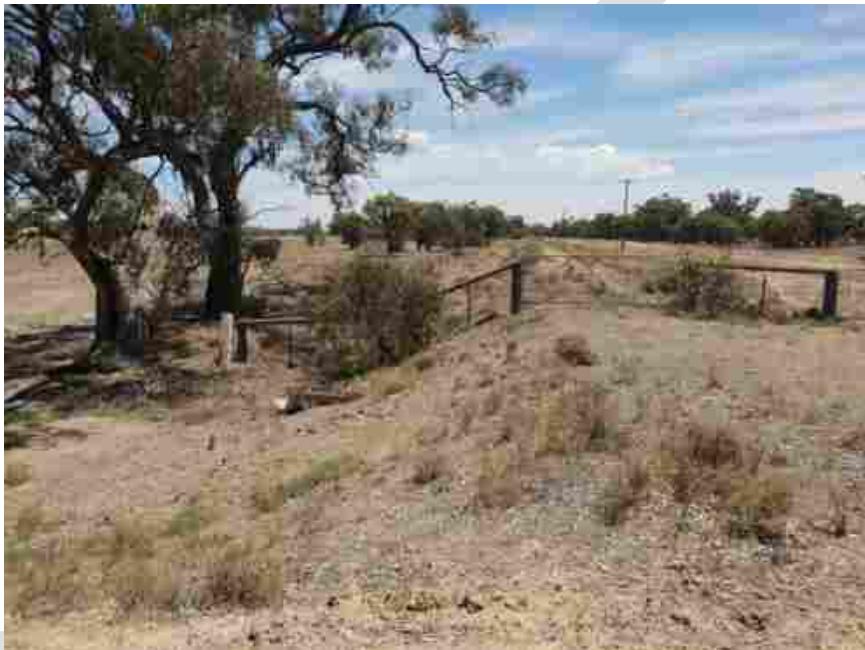
Figure 19: Levee north of Smart Street to be raised 200mm

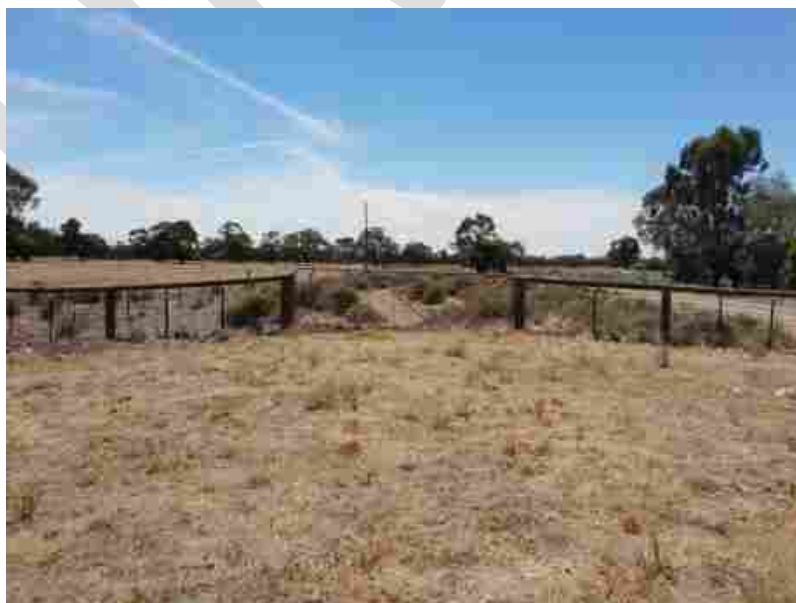
Figure 20: Levee north of Cobb Highway to be raised 200mm

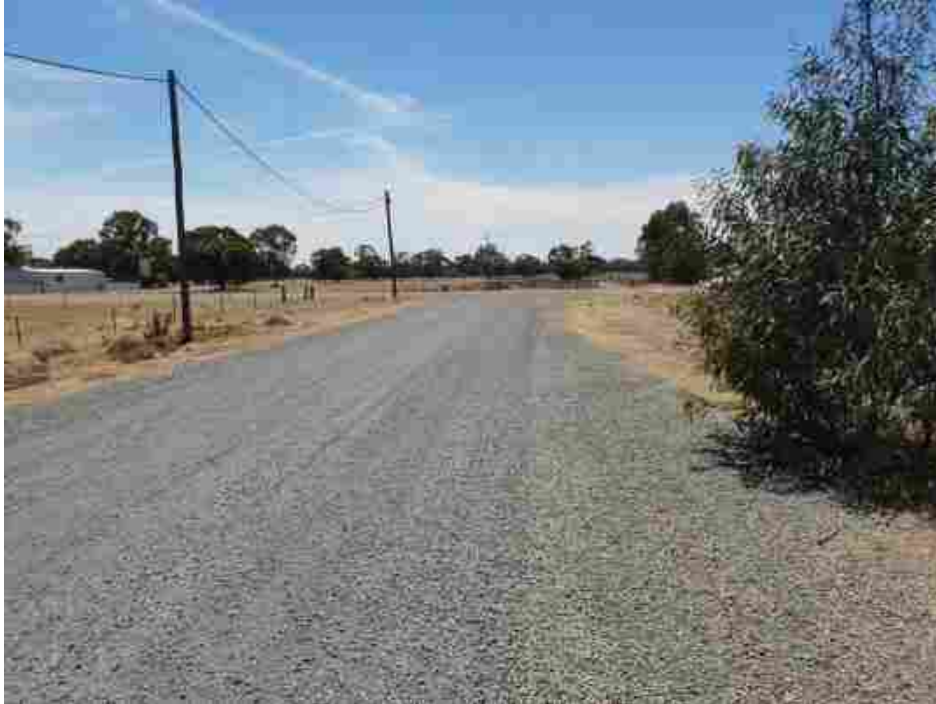
The centreline of the Cobb Highway at the junction of the levee is 92.16 which is 120mm above the 1% flood level. Temporary earth barrier would be placed across Cobb Highway. A stockpile exists to the south west of the intersection. The edge of seal is currently around 100mm below the 1% AEP level. From the Cobb Highway, April Street is a gravel road which is currently around 8m in width.

Figure 21: Looking west along April Street towards Cobb Highway

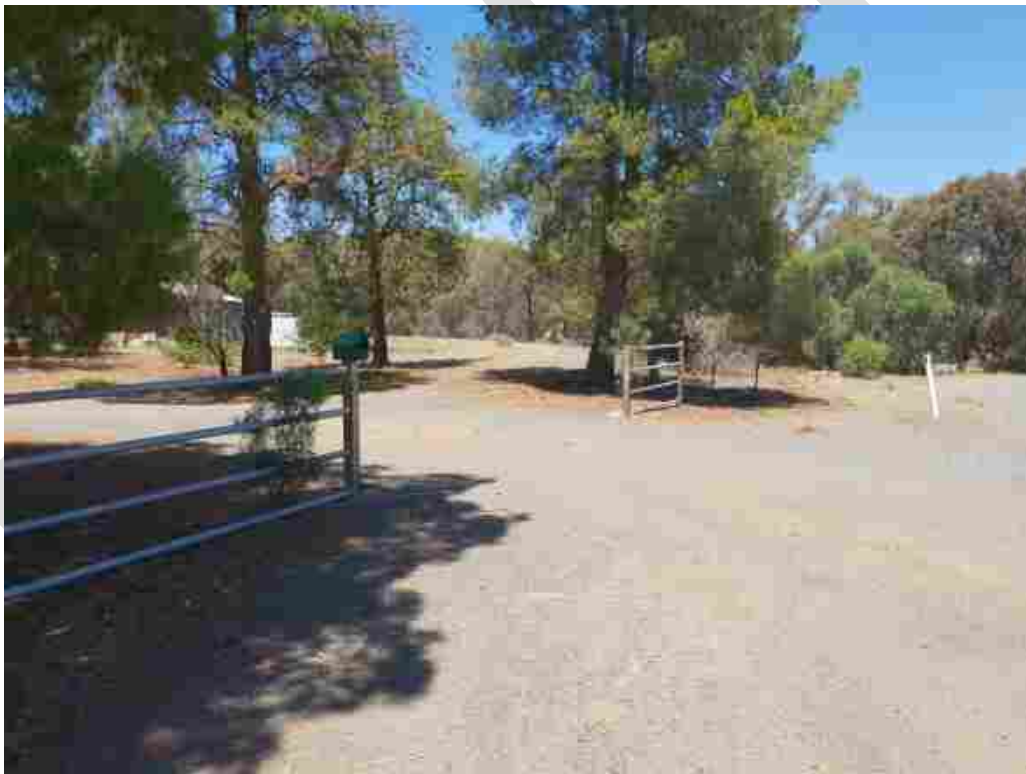
Figure 23: Entry to private property from April Street.

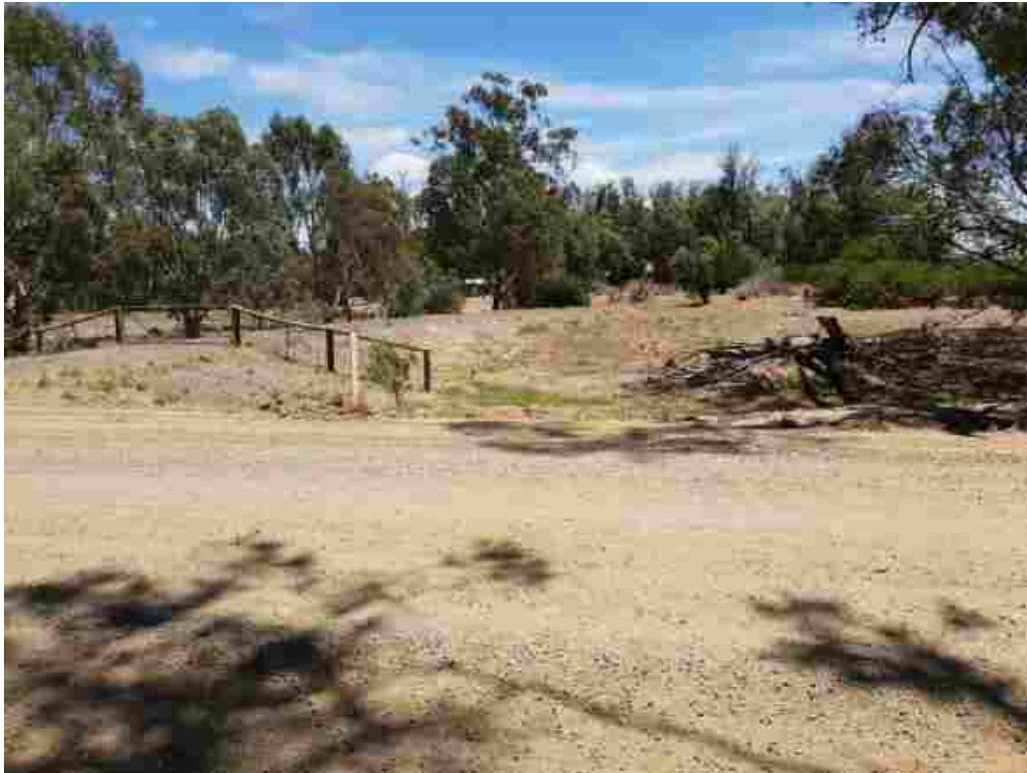
Figure 24: Levee through No: 156-168 April Street onto Smart Street.

Where the levee meets Smart Street at CH 4640 (Figure 24), the centreline of the road is 92.20. Refer to Sheet 18 of PMC drawings for details of levels. The 1% flood level is 92.10 so the current road centreline has 100mm freeboard. Smart Street falls away heading west at a grade of 2% so raising the road will need to consider reduction in sight lines for vehicles. Heading east from the levee intersection the road levels raise slightly to 92.4 before falling back towards the highway. At the north side of Smart Street and north of the existing levee, the toe or drain bed is approximately 1.9m below the edge of road. This steep drop off currently at 2.5(H):1(V) would make raising the north side of Smart Street problematic as it nears the levee. The south side of Smart Street is much flatter with a level difference of 600mm at the levee or 8(H):1(V) batter.

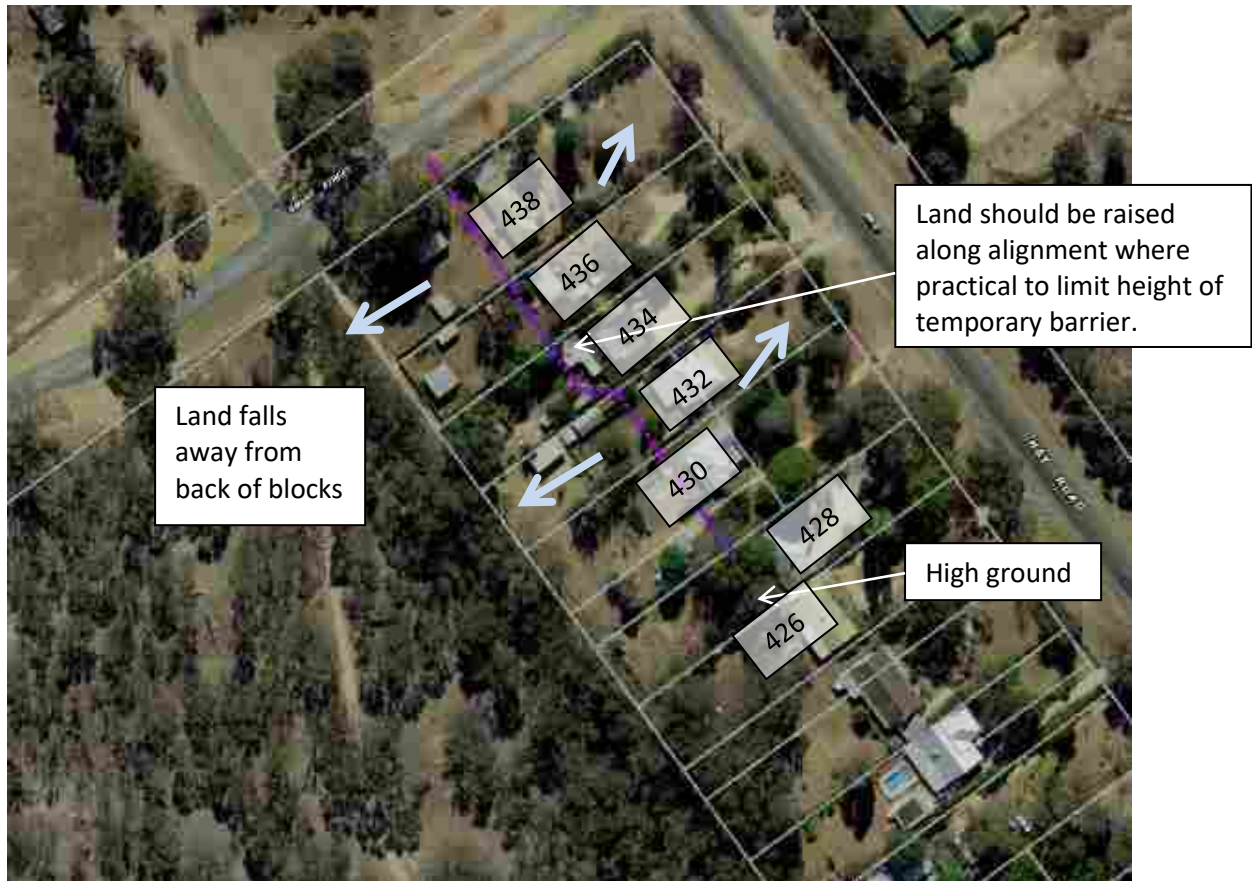
Ground levels vary along the proposed levee alignment with a low dip through 436 to 430 of approximately 91.6. To achieve the 500mm freeboard a barrier of 1.2m is required. To achieve the full height with a temporary barrier would be costly and more susceptible to failure. Earth barriers of this height would be hindered due to fencing and other infrastructure. **It is recommended that portion of the alignment be raised close as practical to the design level including freeboard. This section will be subject to further consultation.**

Figure 25: Section 9 - Temporary Levee through properties No. 438 to 428 Hay rd.

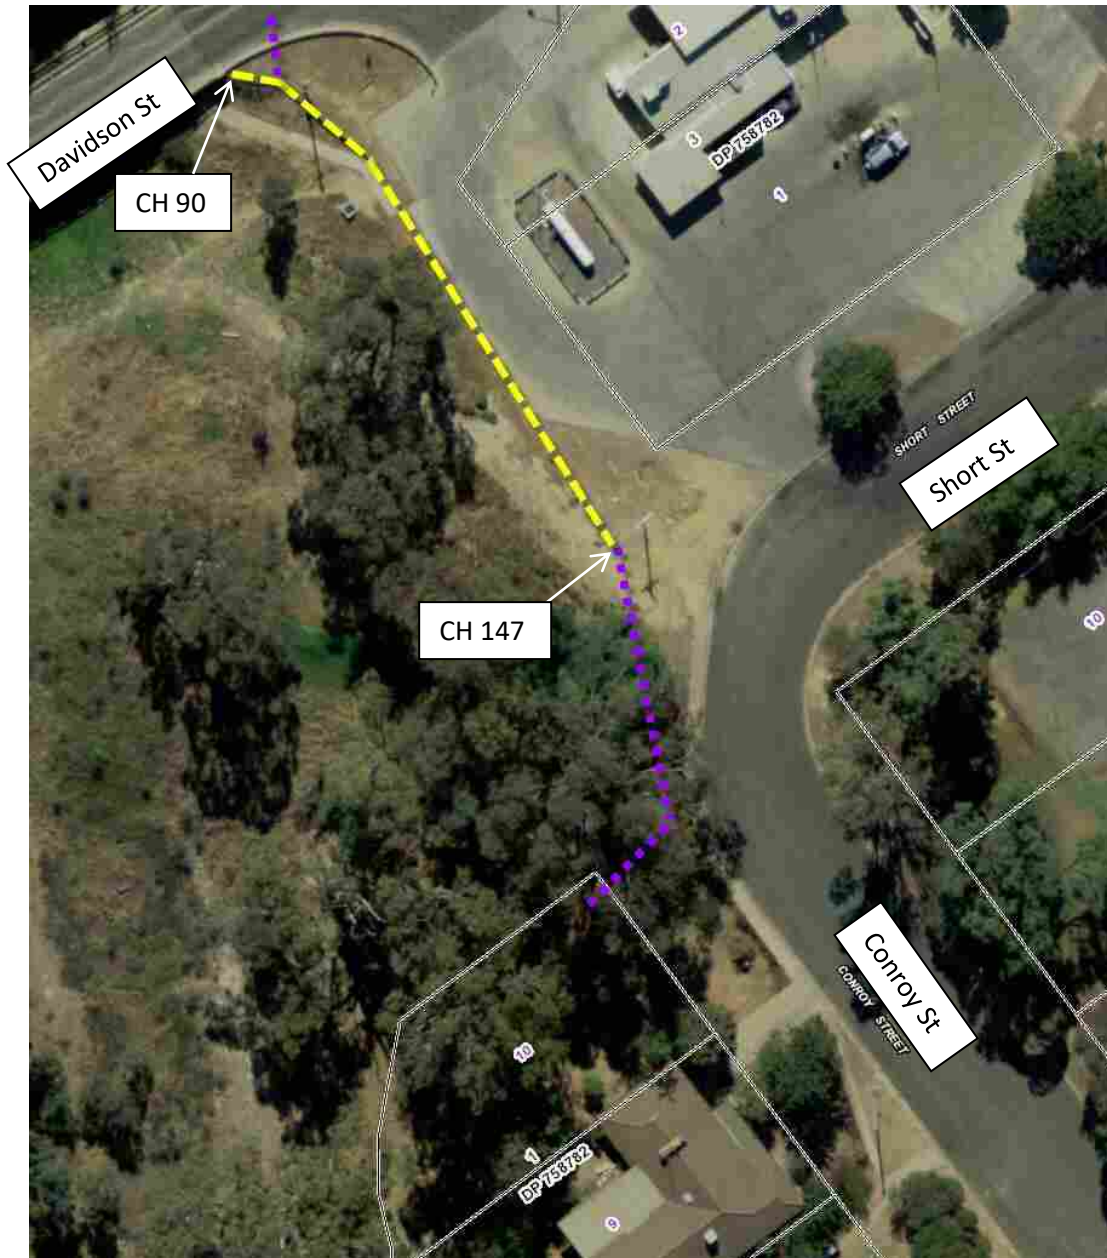
The existing concrete wall is approximately 100mm below the 1% design flood level. Temporary system to attach onto the existing concrete wall is proposed to provide freeboard of 500mm.

Figure 28: South East side of Davidson Street to Conroy Street

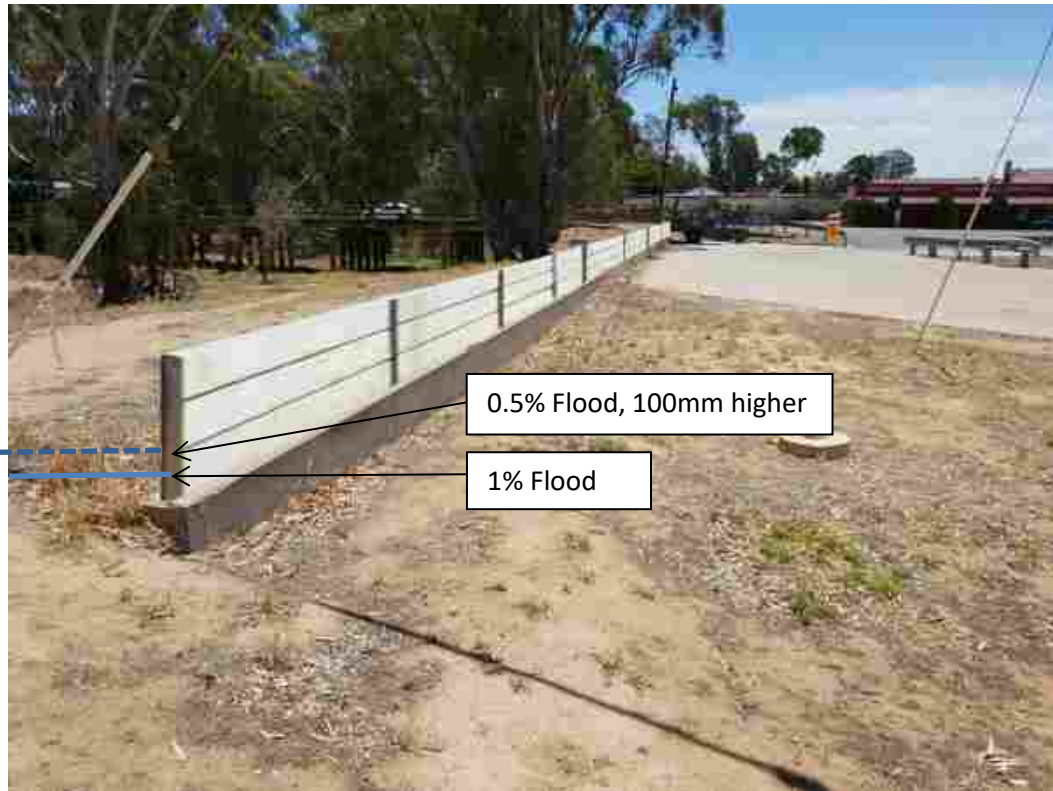
Figure 29: Realistic impression of sleeper retaining wall on existing wall.

Temporary system such as NOAQ wall or similar would be connected to the end of the wall attachment. This type of system is discussed in Section 7 at length, however it comprises moulded heavy grade plastic sections being joined together in order to act as a barrier.

If there is a high chance of the sleeper retaining walls being subject to water for a prolonged amount of time, it is recommended an impervious barrier be placed on the wet or river side to prevent leakage. The amount of leakage expected through wave action is negligible and would be collected within the town drainage system. Pumps are likely to be deployed in a high river event for the town drainage system which can also account for any seepage issues. Each wall section is 200 high therefore a design 1% flood event would be around half way up the bottom sleeper row. Note that the 0.5% (1:200 AEP) is only another 100mm higher than the 1% event which would be at the top of the bottom row of sleepers.

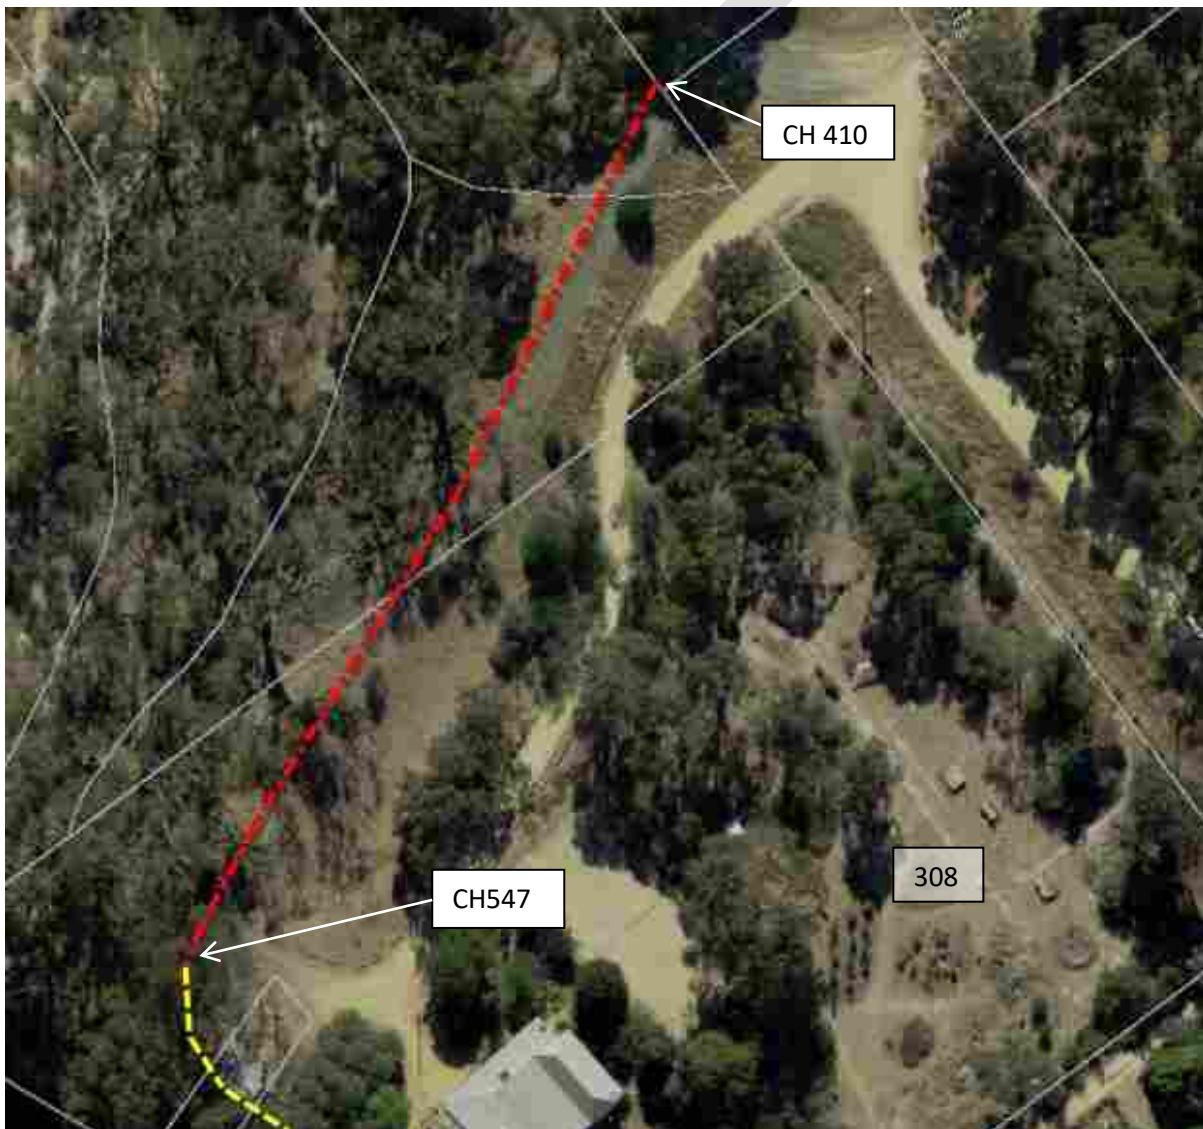
Figure 30: Hyde Street to Water Tower

The existing bank between CH 410 and CH 547 has a 3.6m crest at 92.45. This is about 200mm below the 1% flood level. To achieve 500mm freeboard the bank would need to be raised or flood protection measure to provide 700mm additional height. The batters of the existing bank are around 4(H):1(V) on the wet side and slightly flatter on the dry side. The height of the bank is around 2.3m.

Raising the bank with earth fill is not practical due to the height and impact the bank would have on existing vegetation. Large temporary concrete blocks are another option that could be deployed however due to the space constraints and resources to place the blocks they are not recommended. Therefore due to the limited area to work within, a retaining wall system is proposed.

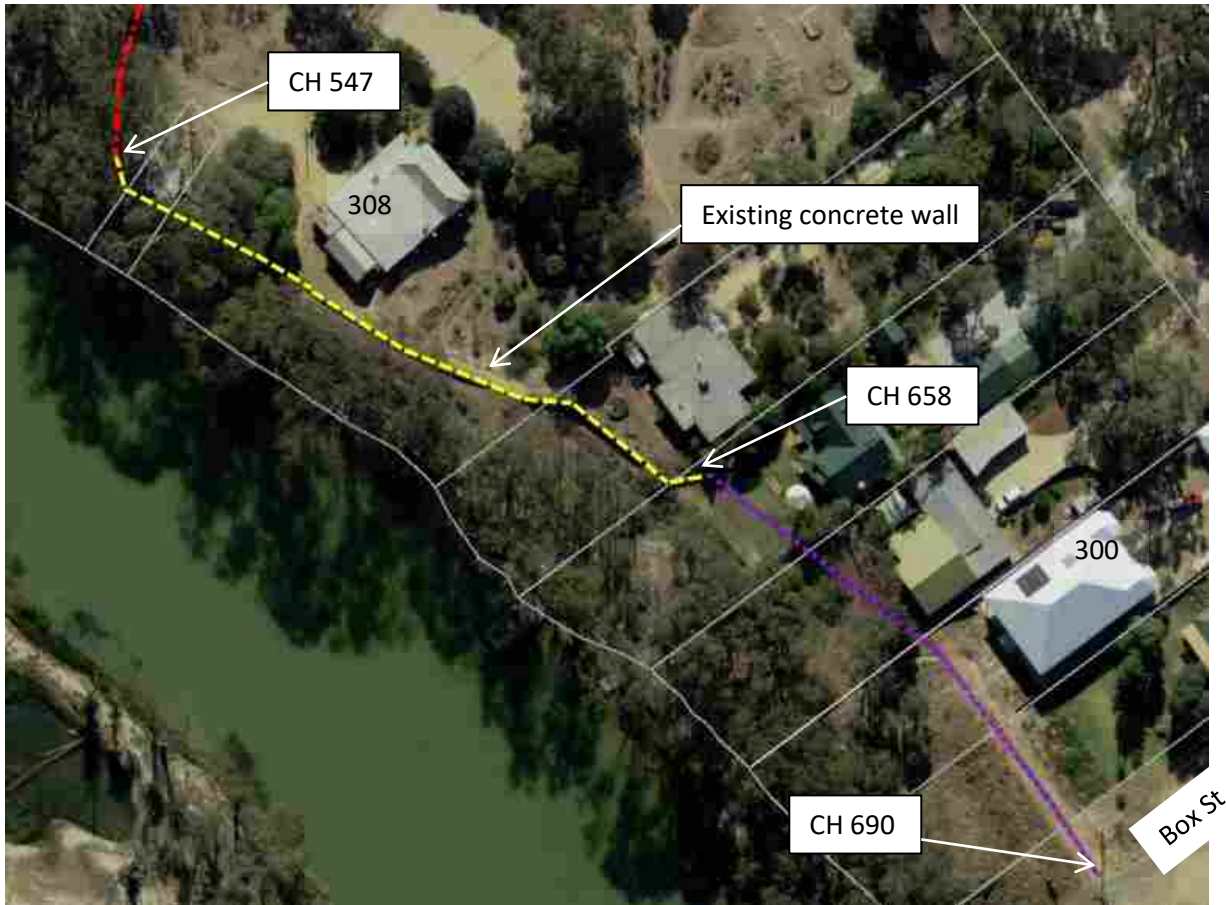
Figure 33: No. 308 River Street – existing concrete wall

The existing concrete wall is approximately 150mm below the 1% flood levels. In this section the retaining wall height to the property side is up to 1.6m above surface levels.

This section of wall contains a Council pump station which is located on the concrete wall. It is understood this structure would be made redundant in the near future.

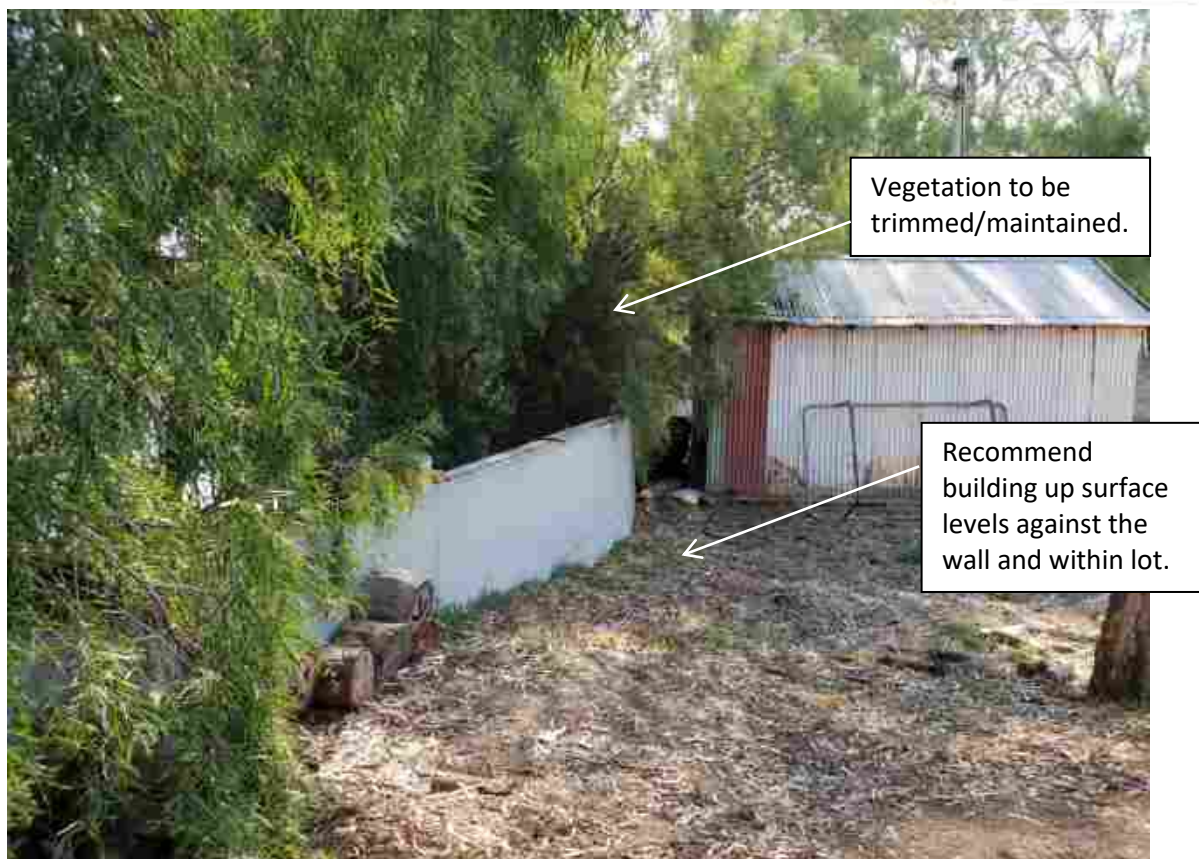
Figure 34: Photo looking at CH 570 where concrete wall is highest above surface level.

Due to the height of the wall approximately 1.5m above existing ground level near the pump shed, it is recommended that fill be placed on the dry side of the existing retaining wall to assist in the deployment of temporary barriers. The width should be a minimum 3m to provide sufficient access for a service vehicle.

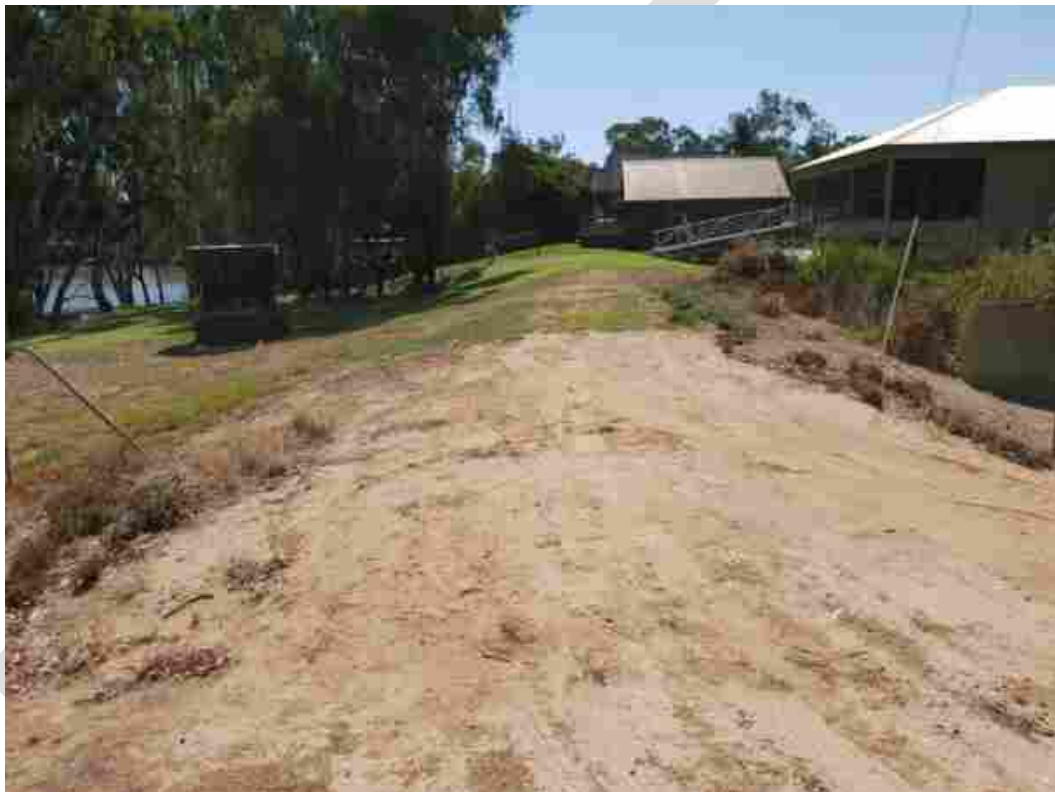
Figure 35: Box Street looking north – 298 on right

This existing bank crosses properties No. 304 to 290 at close to the 1% flood height. To match the 1% level height, filling of approximately 200mm would be required from 298 to 290 for a length of 80m. Temporary barrier system such as NOAQ box wall (\$400/m) or similar would be required to provide the additional 500mm freeboard. Locating the high ground is difficult to determine on visual inspection as it travels through landscaped yards. It is recommended that at boundary fences a connection post or system that is permanently fixed would give an understanding of the required height to achieve 500 freeboard. This would also help define the alignment and provide ability to fix barriers onto.
