North Deniliquin Levee Upgrade Feasibility Report

F8480

Project Name	North Deniliquin Levee Upgrade Feasibility Report
Version Number	2
Client	Edward River Council
Report Authors	Price Merrett
PMC Project Reference	F8480

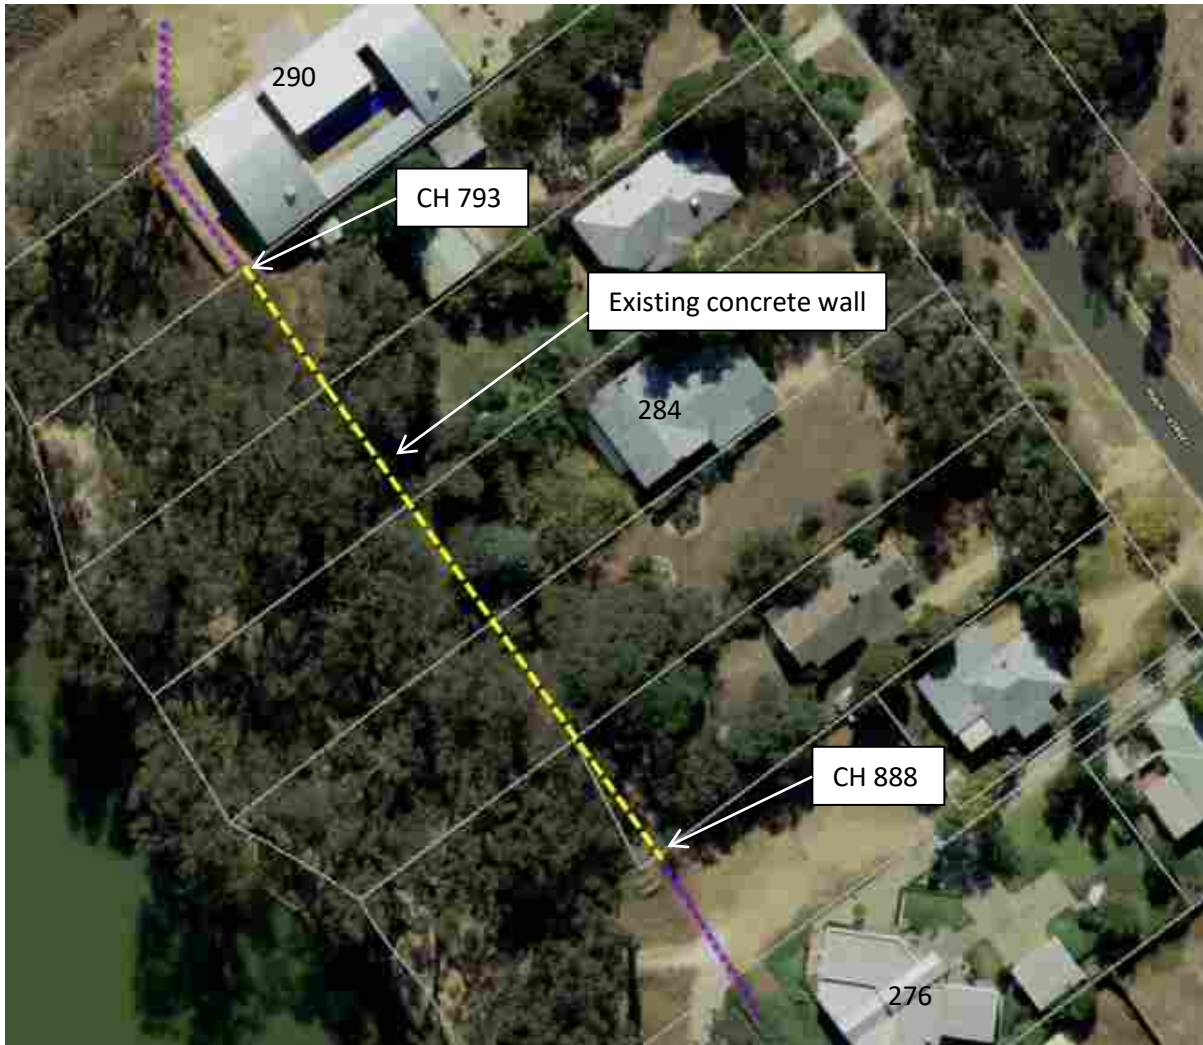
Figure 36: No. 288 to 280 Box Street

The concrete wall section crosses properties No:288 to 280. A temporary barrier system attached on top of concrete wall is proposed. To achieve 500mm freeboard the wall would need to be higher by approximately 600mm.

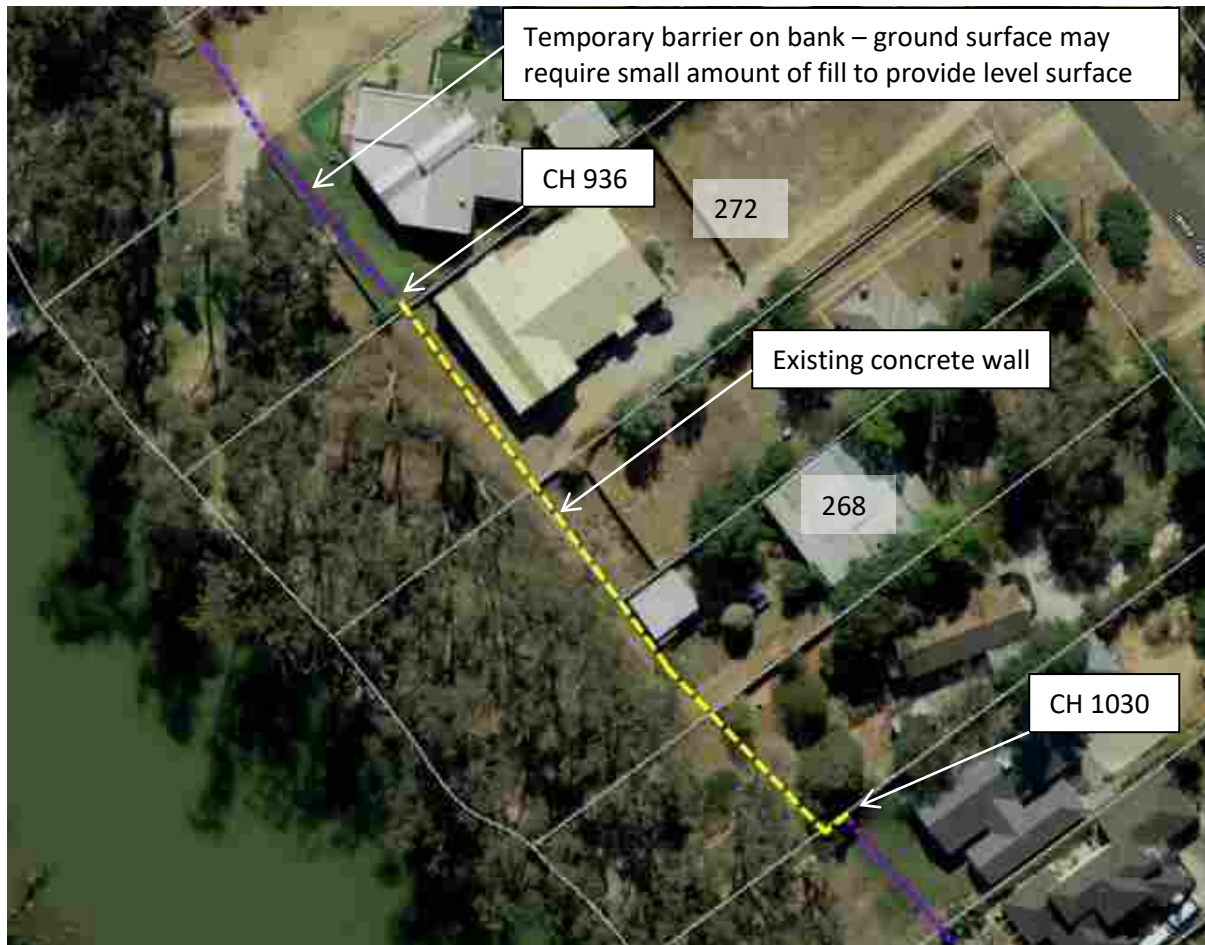
Figure 37: No. 278A to 266 River Street

The levee consists of a bank crossing properties No. 278A and 276 and is 150 below the 1% flood level in some sections. Depending on the type of temporary barrier system chosen there may be some minor filling and levelling of the surface to ensure the barrier system reaches 500mm above the flood level. NOAQ box wall (\$400/m) claims to provide protection up to 0.5m.

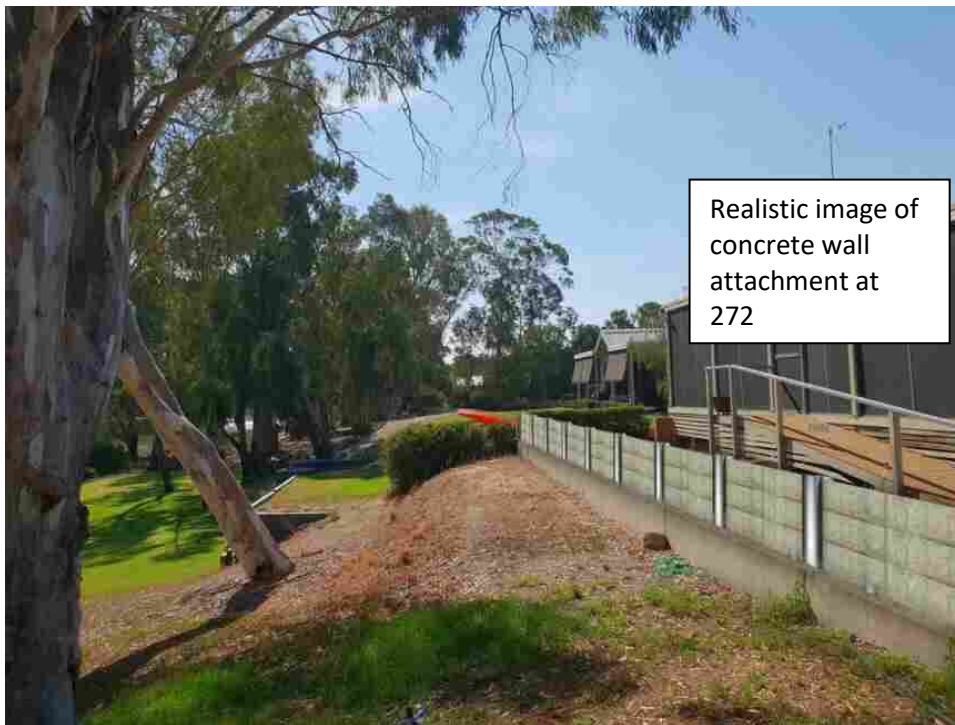
Figure 38: Image of wall at 272 River Street

This section of existing concrete retaining wall crosses properties No. 272 to 266 River Street. Temporary barrier system on top of concrete wall is considered most economical effective. To achieve 500mm freeboard the wall would need to be higher by approximately 600mm.

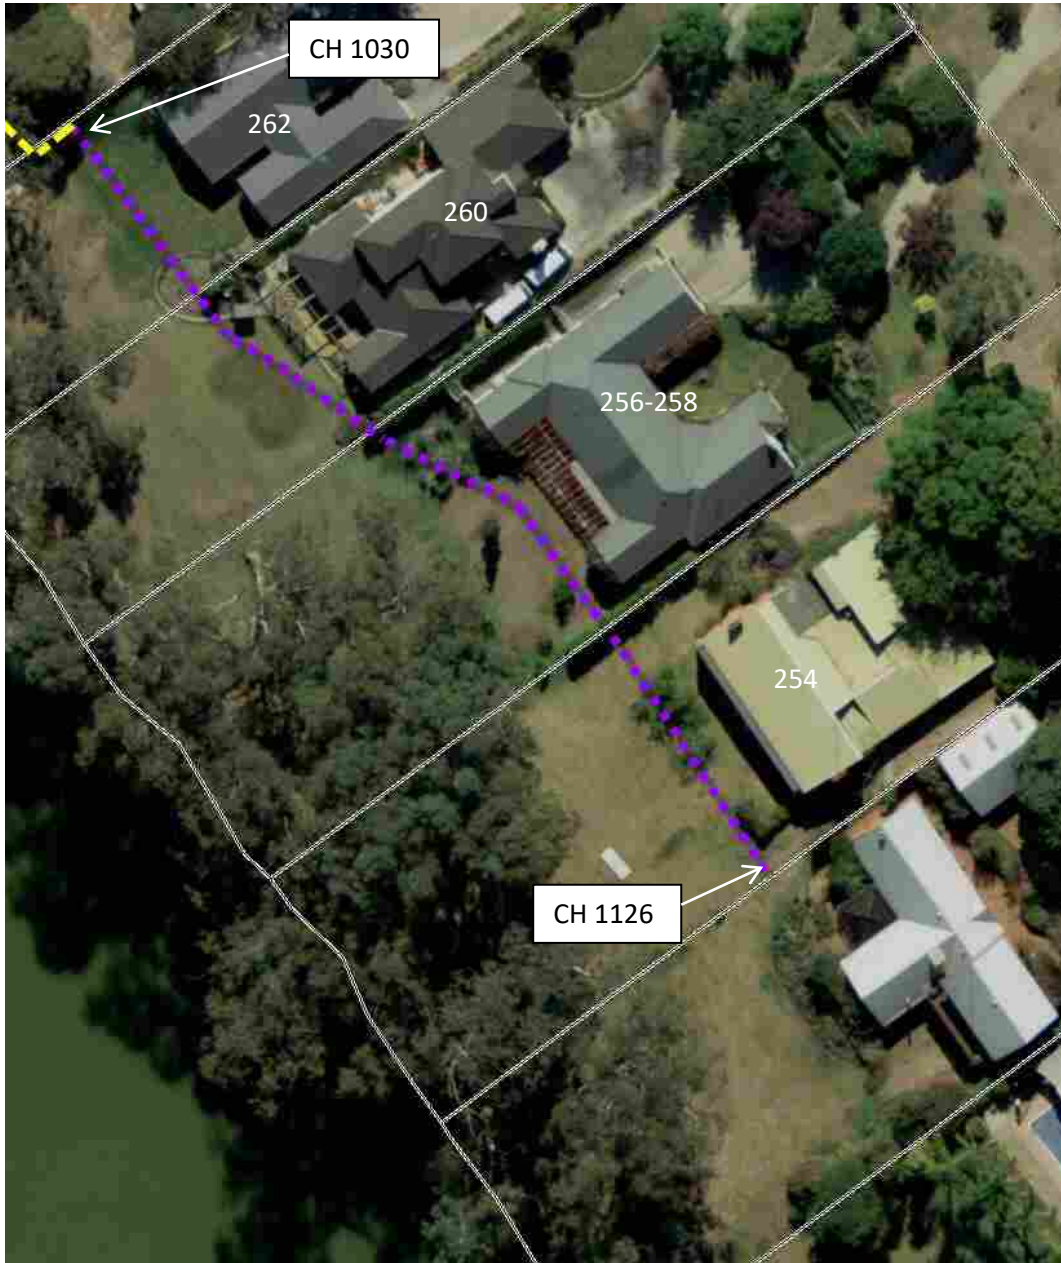
Figure 39: No. 262 to 254 River Street

This is the southern section of the levee system and comprises high ground crossing properties No. 262 and 254. Ground levels vary along the alignment due to changes in landscaping. Typically ground levels are at or just above the 1% flood level. To provide additional 500mm flood protection height it is again recommended that temporary barrier systems be deployed. Alternative options are limited due to impacts to aesthetics.

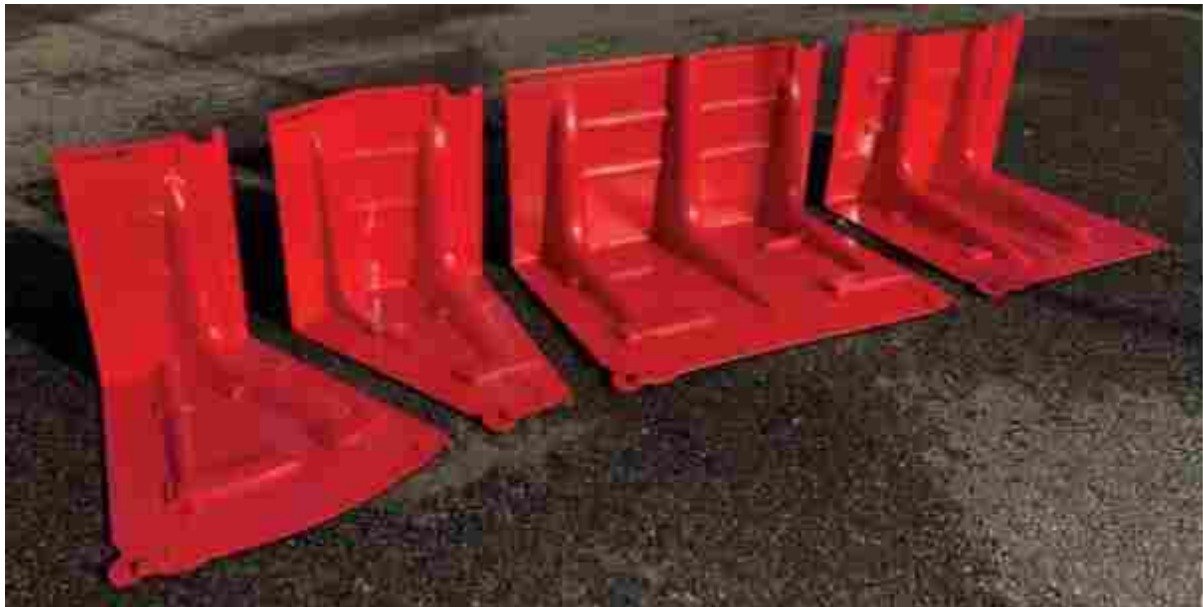
Figure 41: NOAQ Boxwall

The benefits of the NOAQ Boxwall BW52 is it is extremely lightweight, with each section only weighing 6.0kg, making it easy to deploy, and stands firm with no external fastening.

Sections are slotted together and their geometric design allows for curves and corners to be assembled in order to protect existing infrastructure.

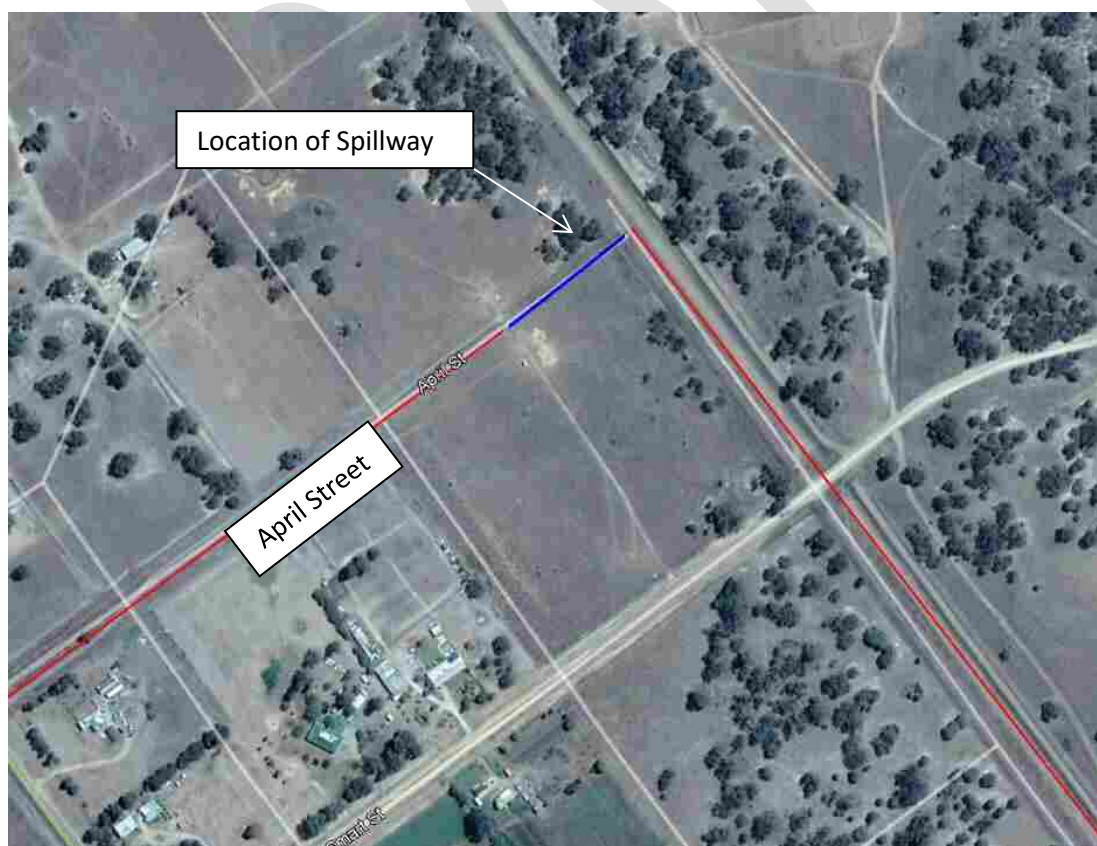
Figure 44: Location of Spillway

At the proposed spillway location the existing bank needs to be lowered 100mm. The bank would be lowered further to provide crushed rock surface.

Batters are usually flatter on the downstream side of a spillway to lessen the impact of erosion from velocity. The crest formation ideally has a fall downstream or towards the flood to minimise water velocity across the crest. In this instance the existing batters of 4:1 would be sufficient due to the low probability of the spillway operating. Stripped topsoil can be placed on the downstream or property side to flatten the batter.

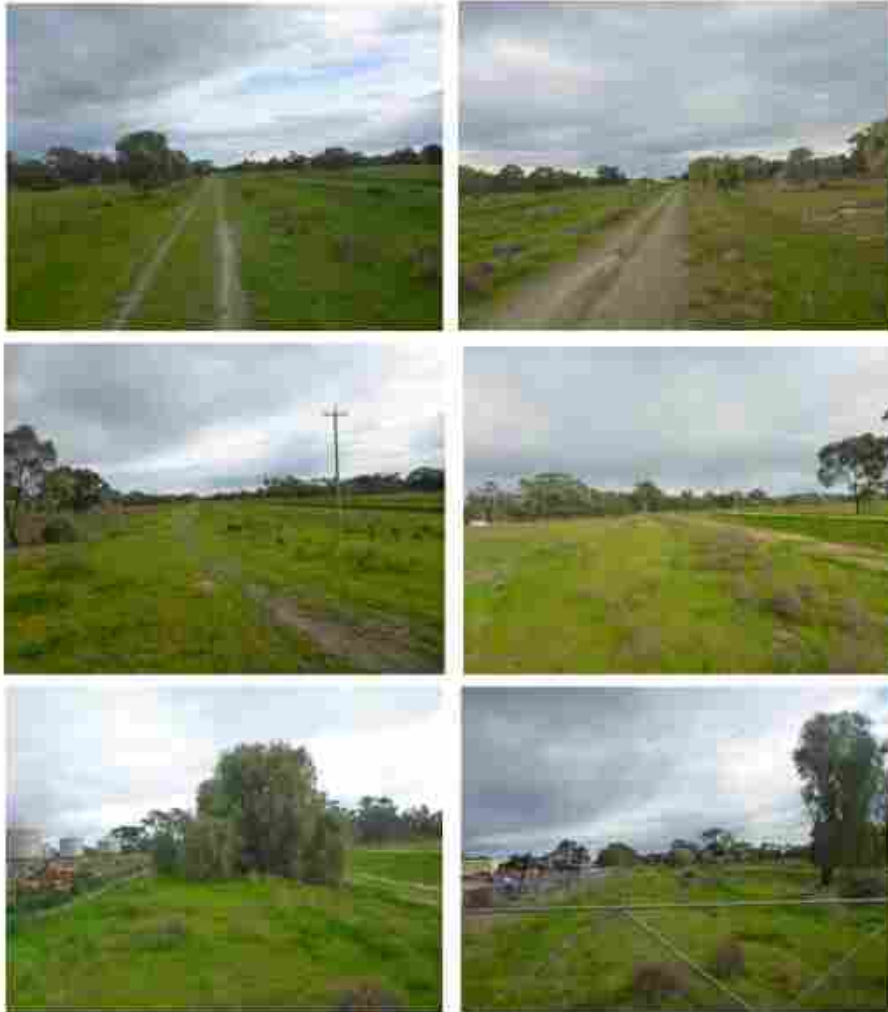
Plate 4-3 Views of Section 5: the central northern part, looking north-west (top left), the central northern part, looking south-east (top right), at the northerly bend, looking north (middle left), at the northerly bend, looking east (middle right), at the southerly bend, looking south-east (bottom left), and from the southern end, looking north-west.

Typical views of the Section can be seen in Plate 4-3.

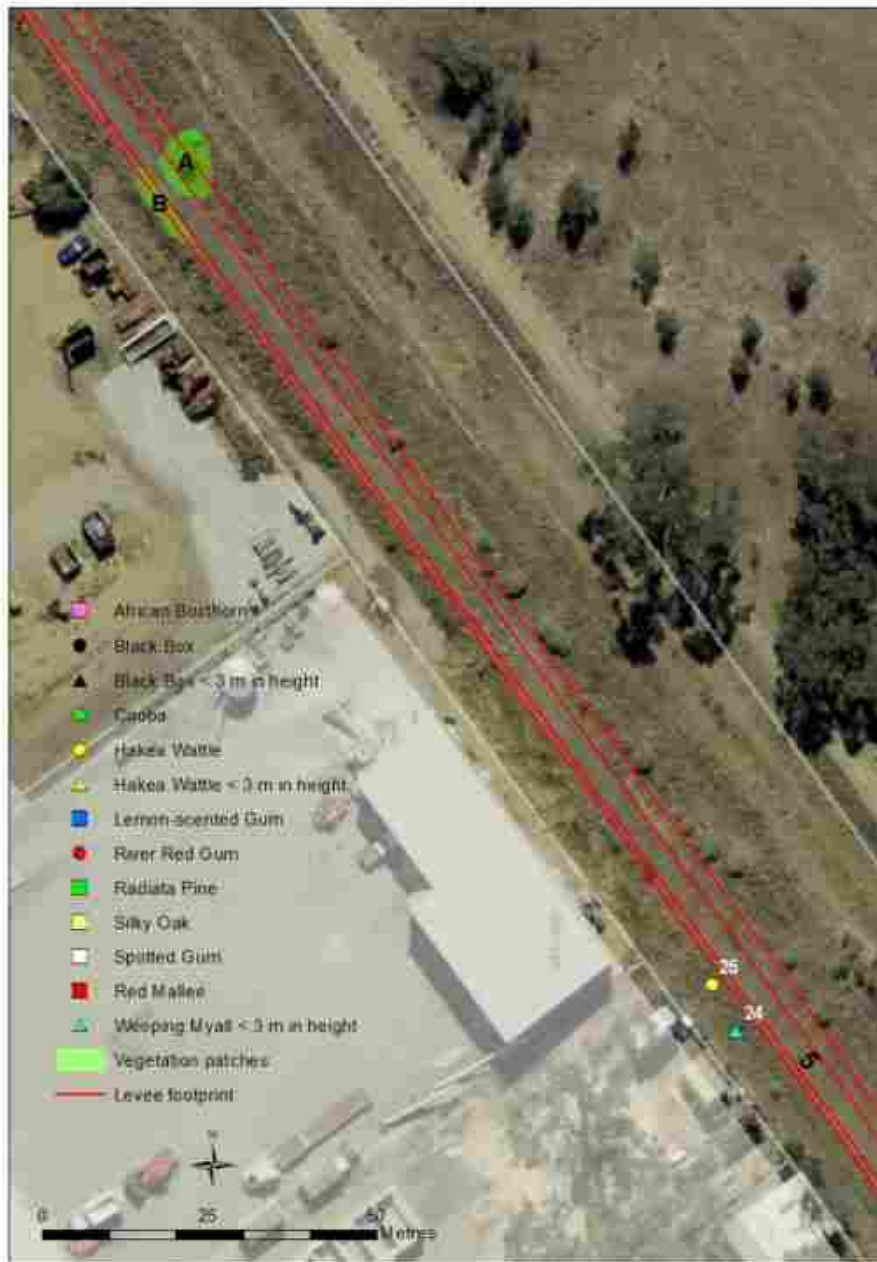
Figure 4-6 Aerial image of the southern part of Section 5 (Image copyright NSW Land and Property Information 2019).

Trees 24 and 25 are regrowth indigenous trees less than 10 years of age (see Fig. 4-6).

Patches A and B are found on the existing levee and are wholly composed of regrowth Hakea Wattle < 10 year-of-age (see Fig. 4-6).

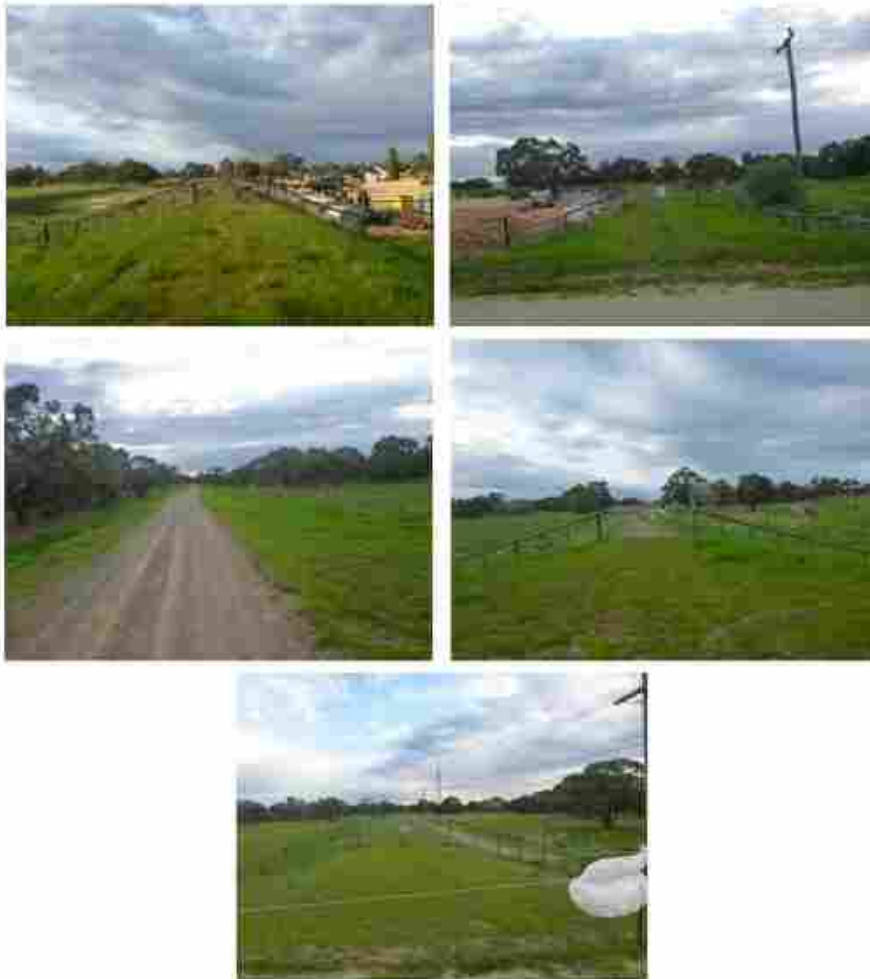
Plate 4-4 Views of Sections 6 and 7: from the northern end of Section 6, looking south-east (top left), from the western end of Section 6, looking north-east (top right), from the eastern end of Section 7, looking south-west (middle left), from the bend in Section 7, looking north-east (middle right), and from the bend in Section 7 looking south-east (bottom).

Typical views of the Sections can be seen in Plate 4-4.

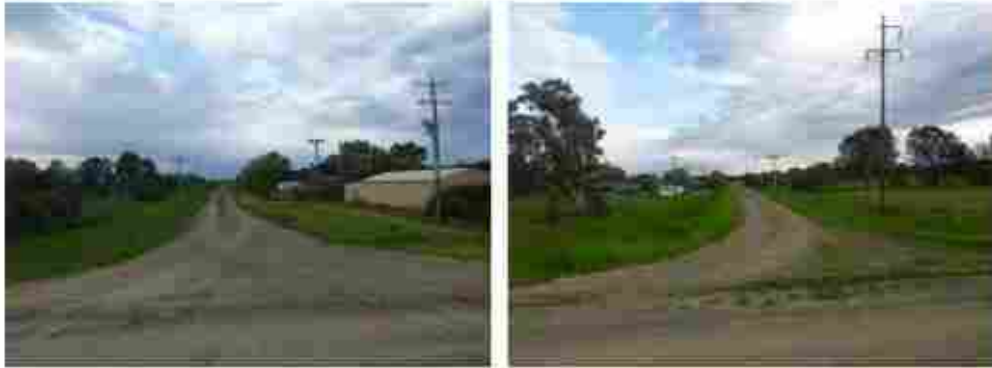
Plate 4-5 Views of Section 8: from the northern end looking south-east (left), and from the southern end looking north-west (right).

Typical views of the Section can be seen in Plate 4-5.

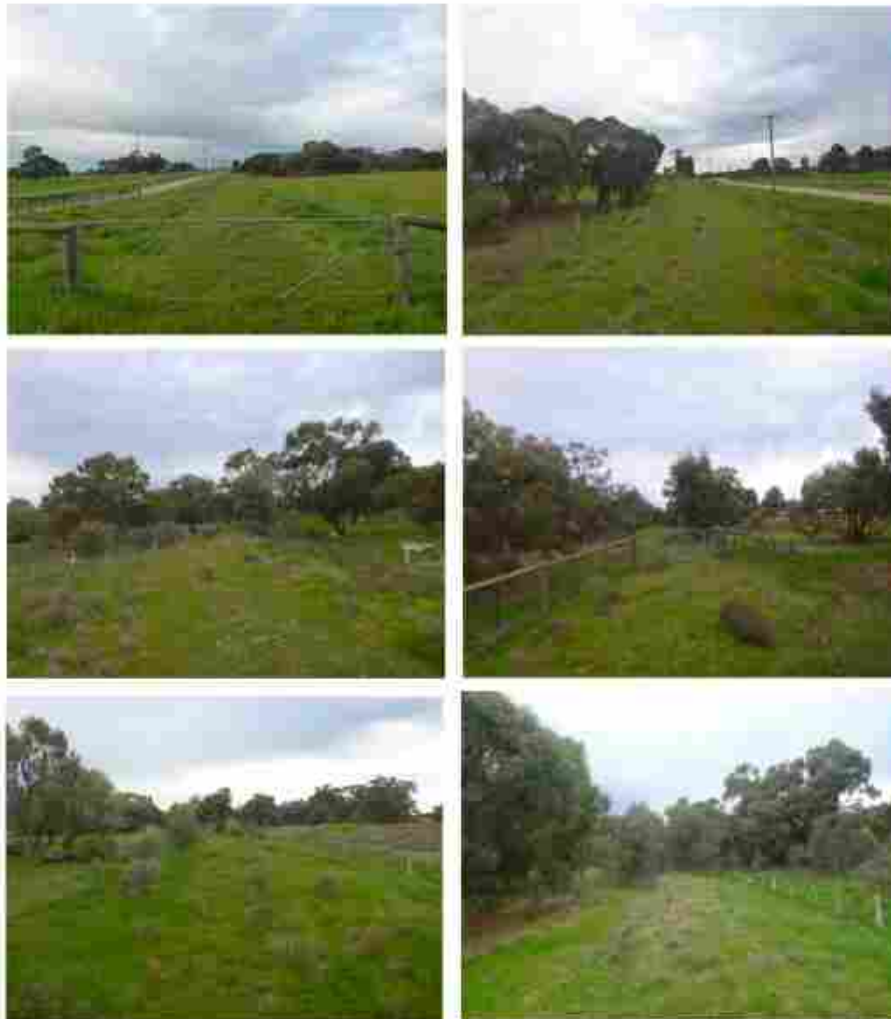
Plate 4-6 Views of Section 9: from the northern end looking south-east (top left), from the northerly bend, looking north-west (top right), from the northerly bend looking south-west (middle left), looking south-west in the central part of the section (middle right), looking south-west in the southern part from the southern end (bottom left), and looking south-west towards the tree patch (bottom right).

Typical views of the Section can be seen in Plate 4-6.

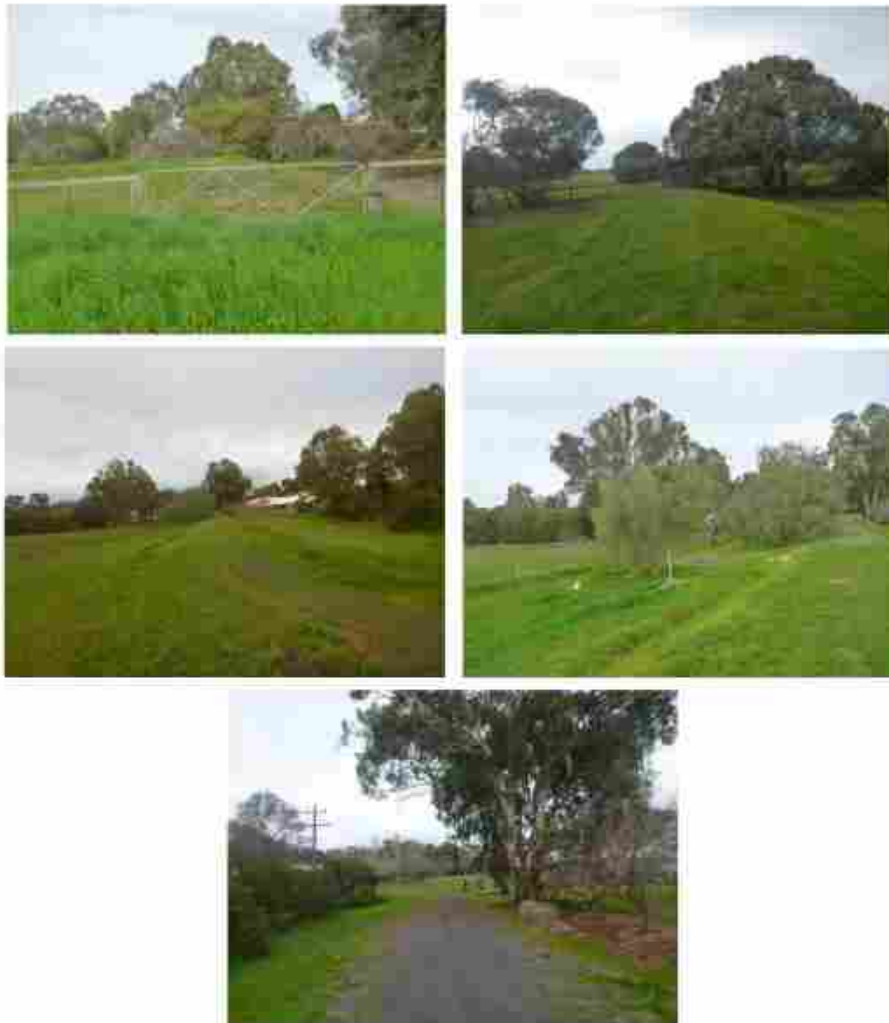
Plate 4-7 Views of Section 10: from the northern end looking south-east (top left), looking north-east towards the bend (top right), looking south-west from the bend (middle left), looking south-west towards Patch C (middle right), and the southern end looking south-west (bottom).

Typical views of the Section can be seen in Plate 4-7.

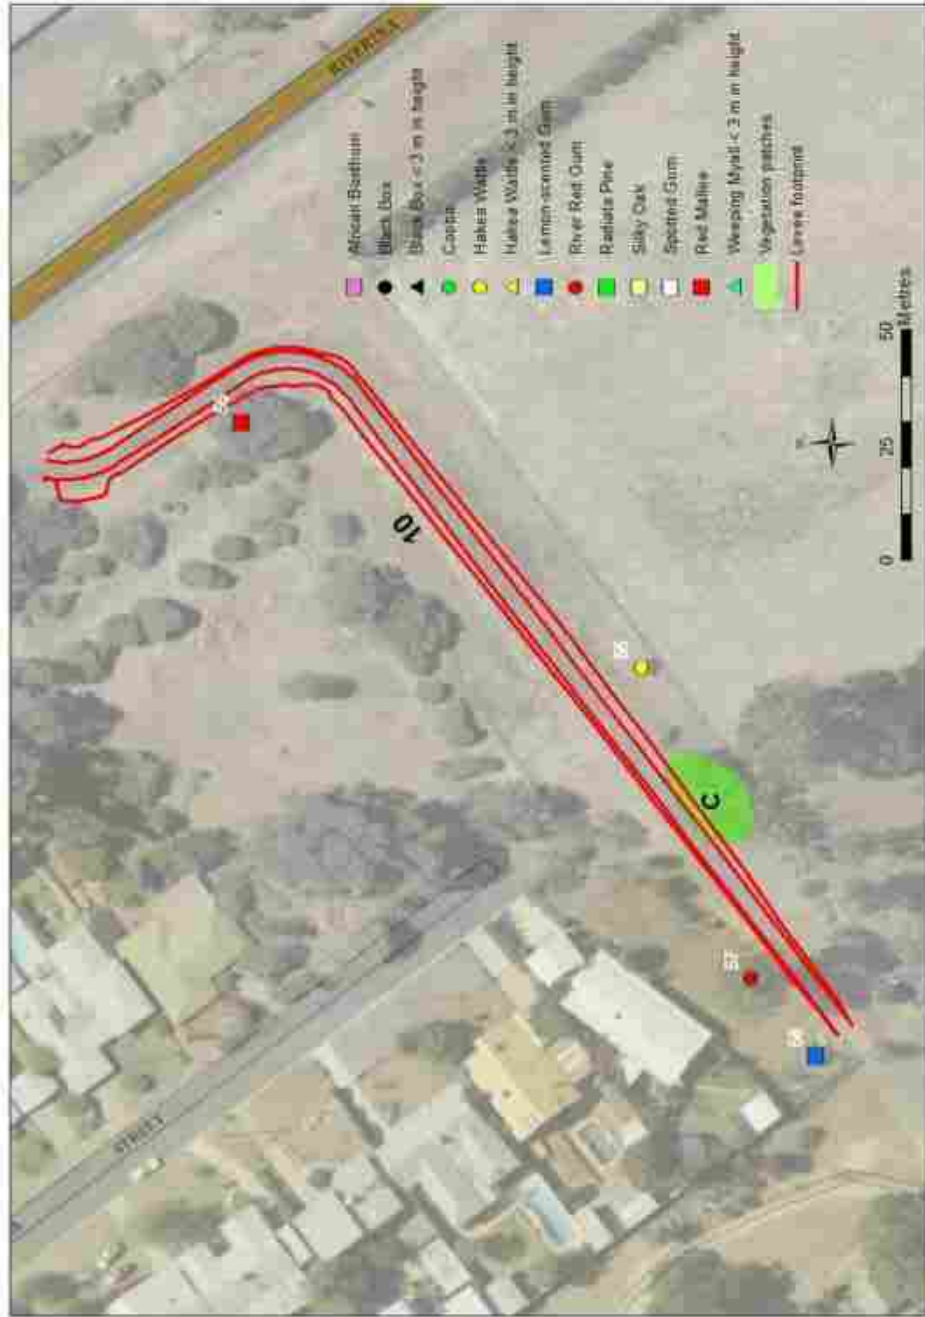
Figure 4-12 Aerial image of Section 10 (Image copyright NSW Land and Property Information 2019).

This Section of 205 m length runs south-east parallel to the Cobb Highway and then south-west towards River Street (Fig. 4-12).

Patch C is found on the existing levee and is wholly composed of regrowth Hakea Wattle < 10 year-of-age (see Fig. 4-12).

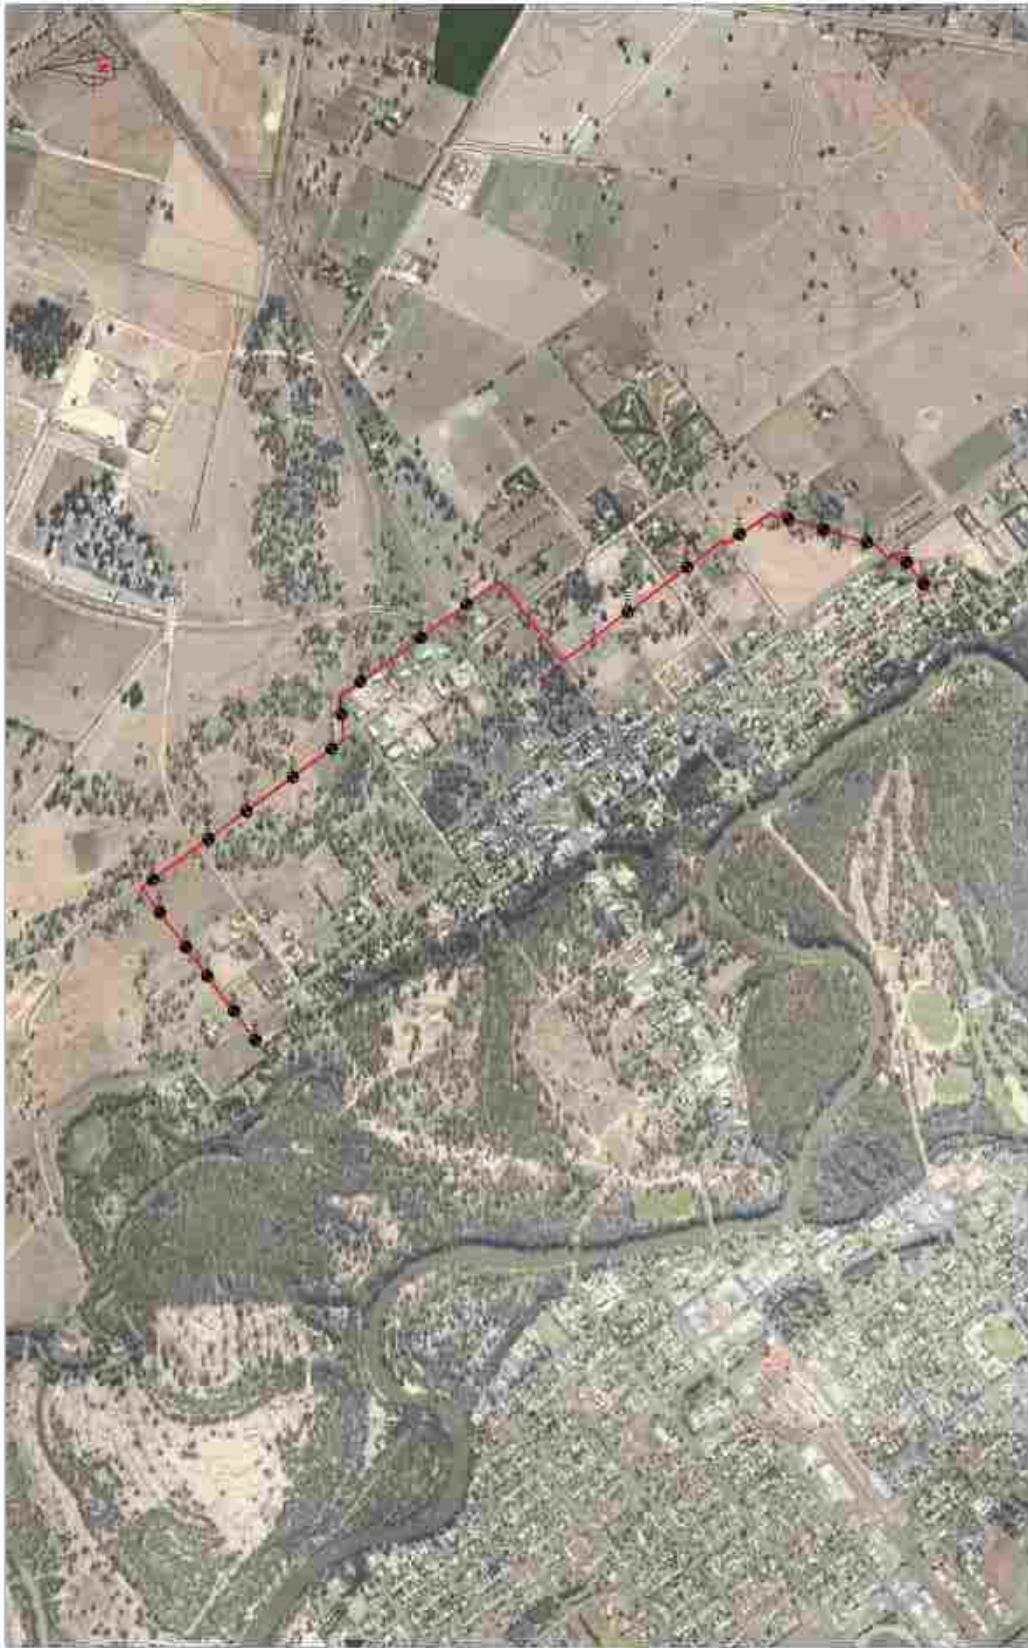
<p>GTS REF: 19C10796 DATE: 24 September 2019</p>	<p>CLIENT: PRICE MERRETT CONSULTING PROJECT: LEVEE BANK INVESTIGATION DENILIQVIN, VIC</p>	<p>GEOTECHNICAL INVESTIGATION APPROXIMATE LOCATIONS NOT TO SCALE</p>
